**The engraved data are not positioned correctly on the plate.**

**To re-calibrate the X-axis home position, proceed as follows**

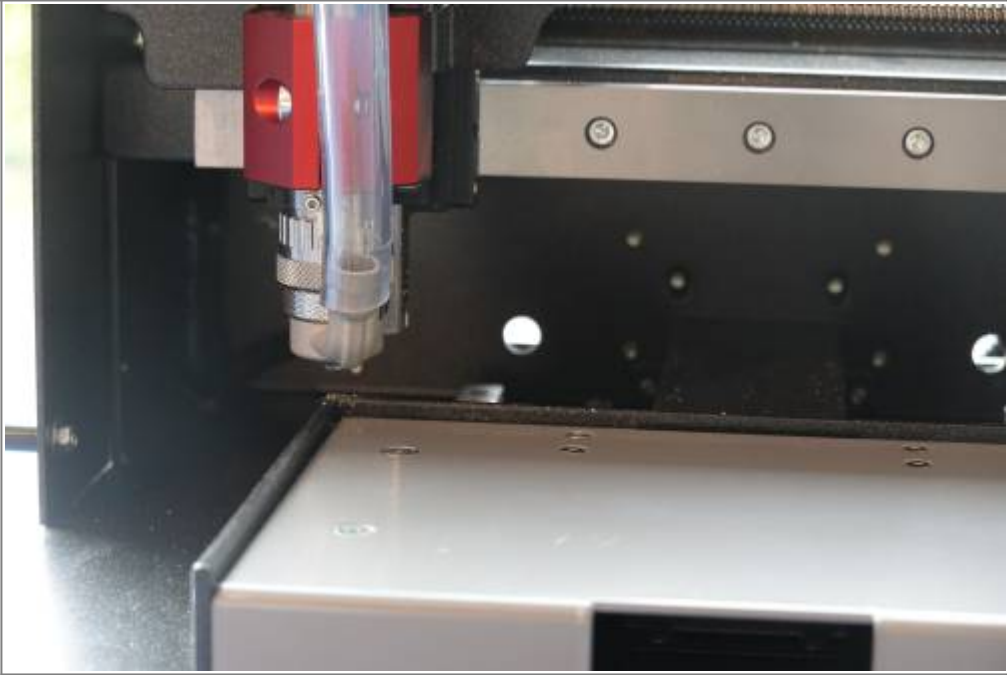
| Image | Description |
|---|---|
| | If there is an engraving plate and/or a Multimat on the engraving table, remove them. |

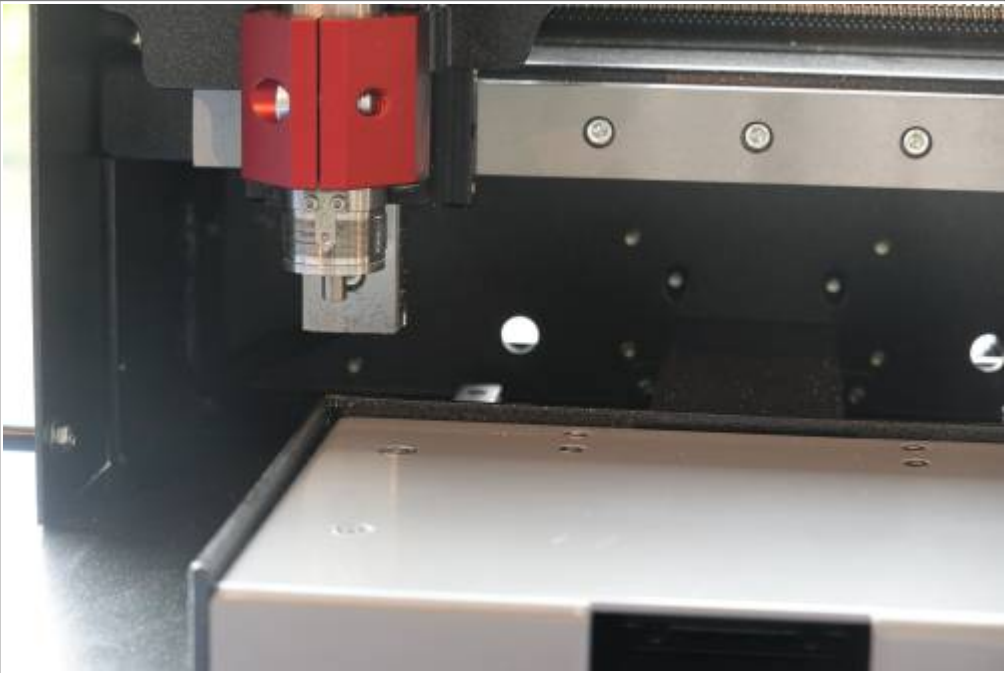
| Image | Description |
|---|---|
| | Remove the depth regulator nose from the spindle. |

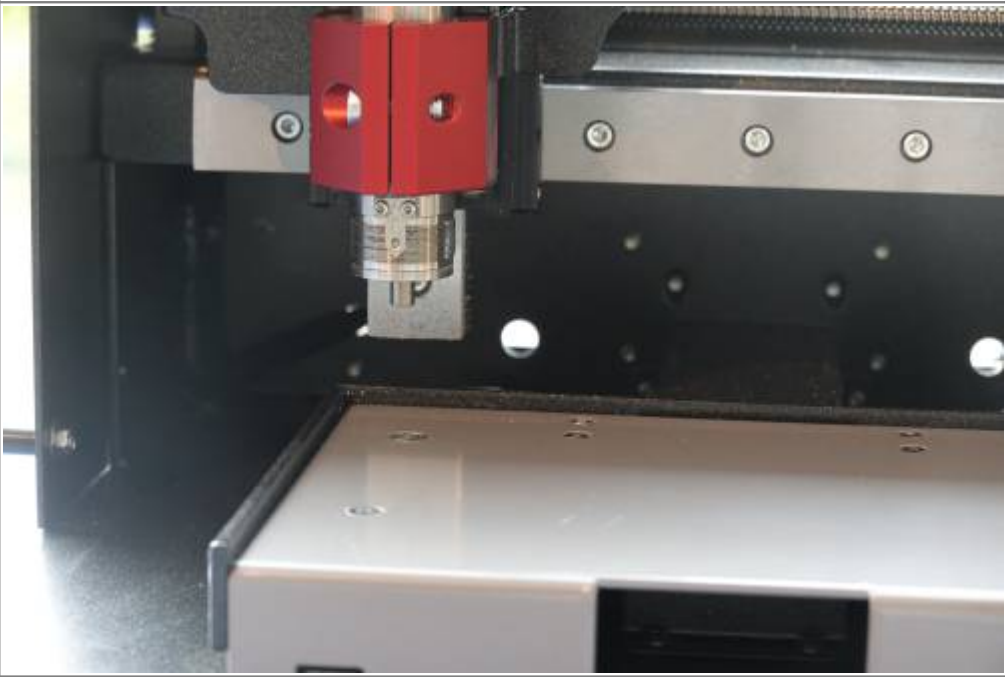
| Image | Description |
|---|---|
| | Jog the spindle some distance away from the upper left corner, both in the X and the Y directions. |

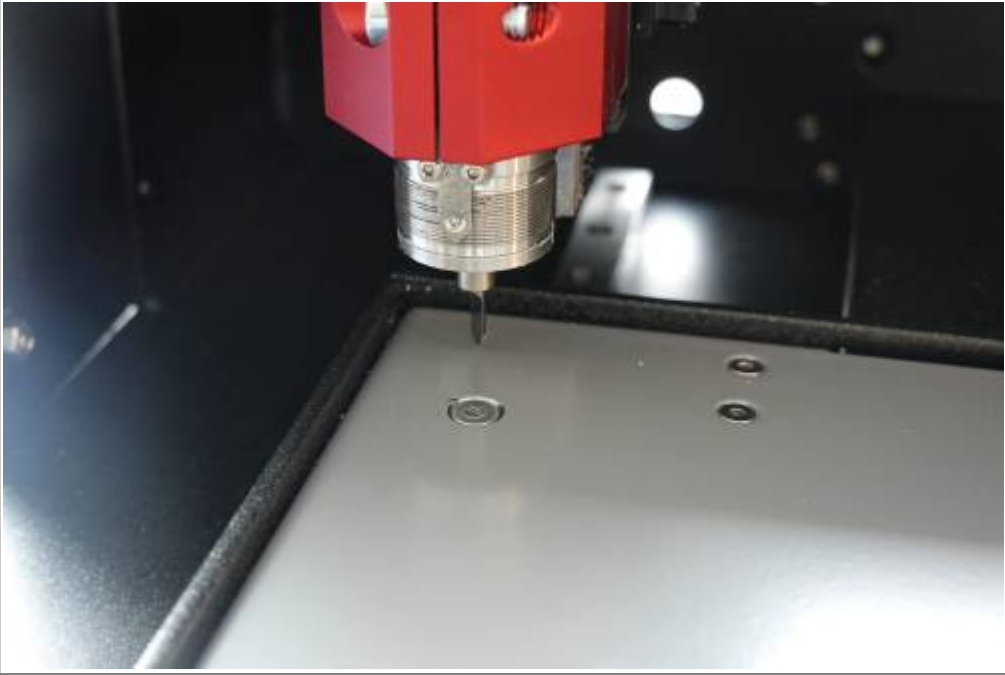
| Image | Description |
|---|---|
| | <p>Jog the Z-axis (the spindle) down till there is about 15 mm distance to the table surface.</p> <p>After that screw a cutter knob counter clockwise in the spindle.</p> <p>Then gently push a cutter through the cutter knob and the spindle. It has to stick out of the spindle at the bottom.</p> <p>Push the cutter through the spindle till its tip is as close as possible to the table surface, but without touching it.</p> <p>Tighten the cutter knob screw.</p> |

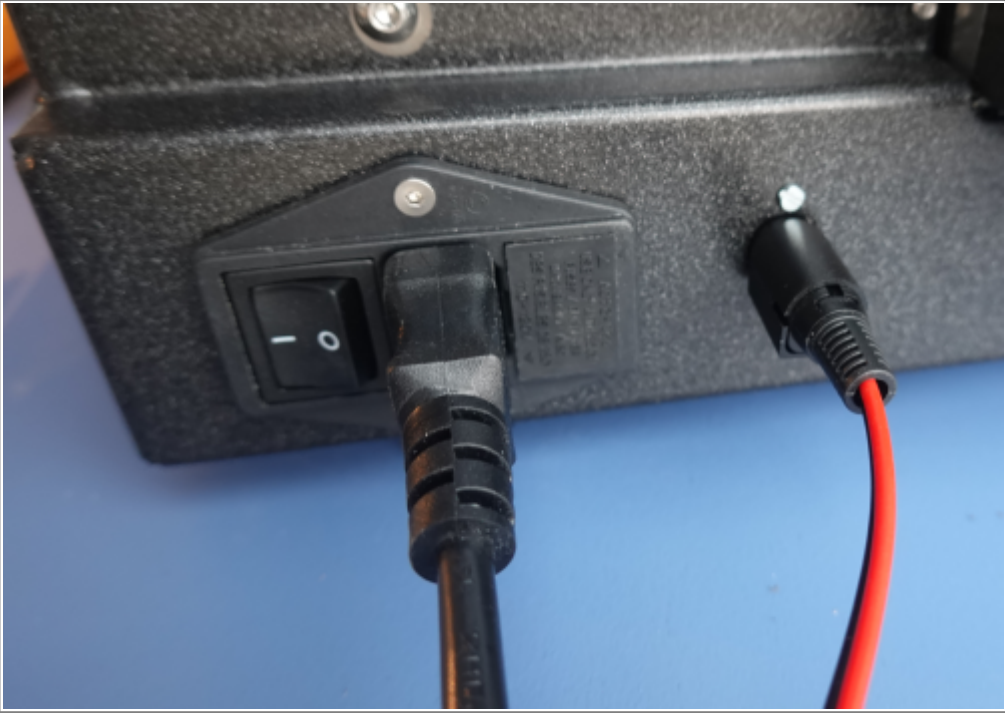
| Image | Description |
|---|---|
| | <p>Switch off the machine using the mains switch.</p> |

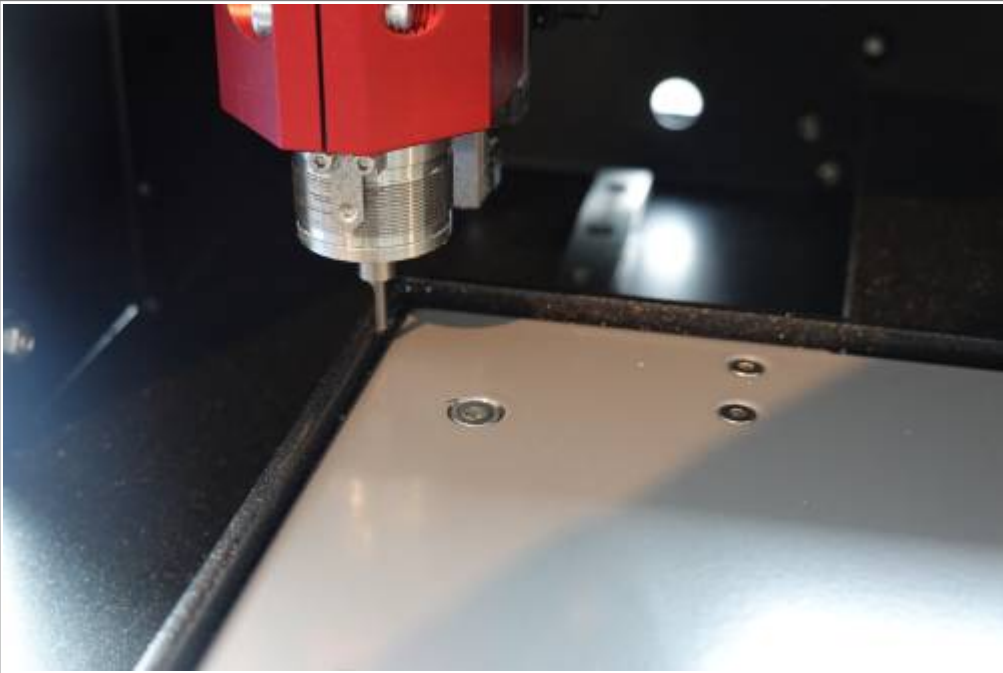
| Image | Description |
|---|---|
| | <p>Gently rotate the black knob on the back side of the X-axis stepper motor till the flat side of the cutter is well aligned with the left table stop.</p> |

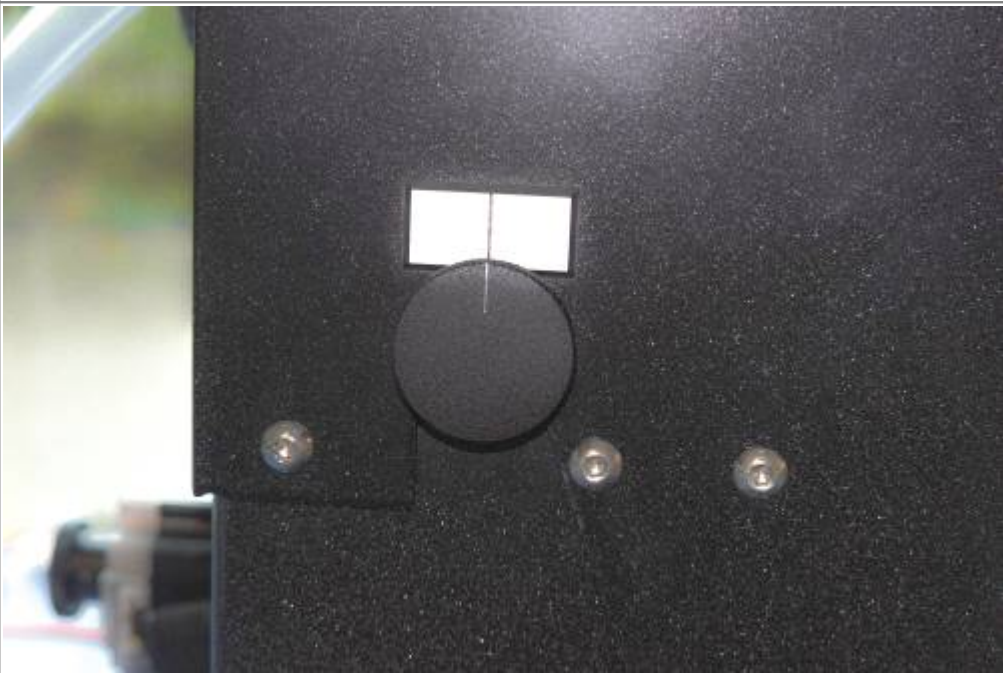
| Image | Description |
|---|---|
| | <p>Now check if the finely engraved line on this knob corresponds with the engraved line on the indicator plate.<br/>If that is not the case, loosen the black knob and rotate it to properly align it with the engraved indicator plate.</p> |

| Image | Description |
|---|---|
| | Re-tighten this knob. |

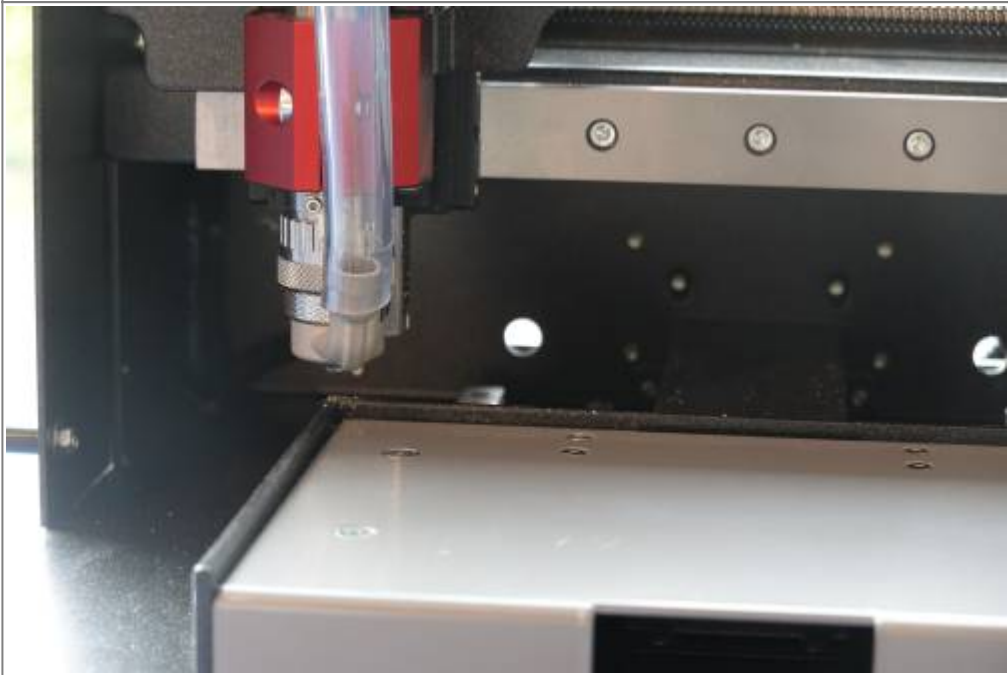
| Image | Description |
|---|---|
| | <p>If there is an engraving plate and/or a Multimat on the engraving table, remove them.</p> |

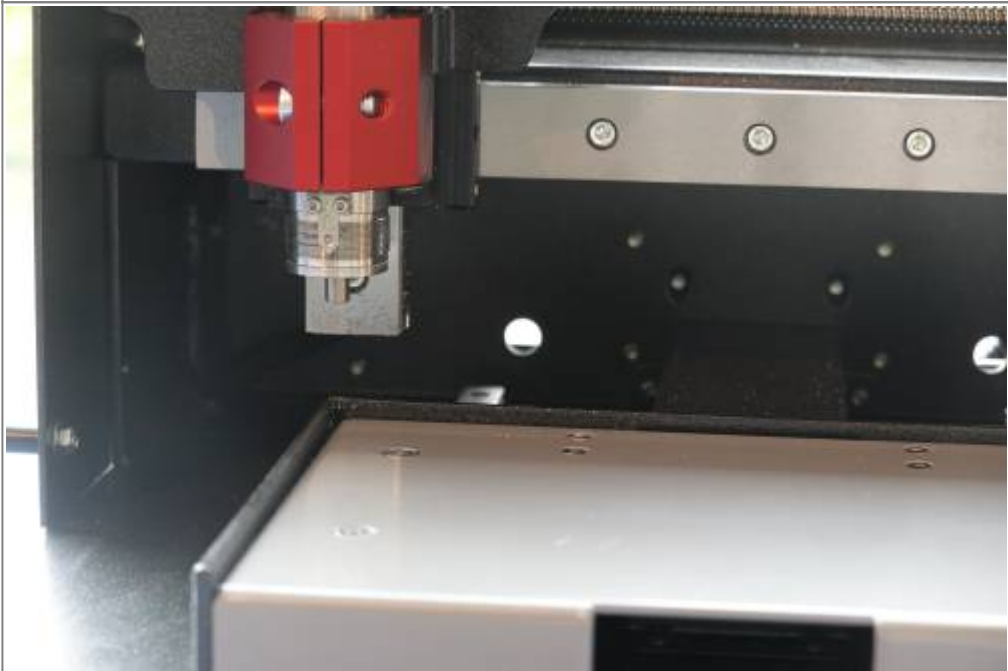
| Image | Description |
|---|---|
| | <p>Remove the depth regulator nose from the spindle.</p> |

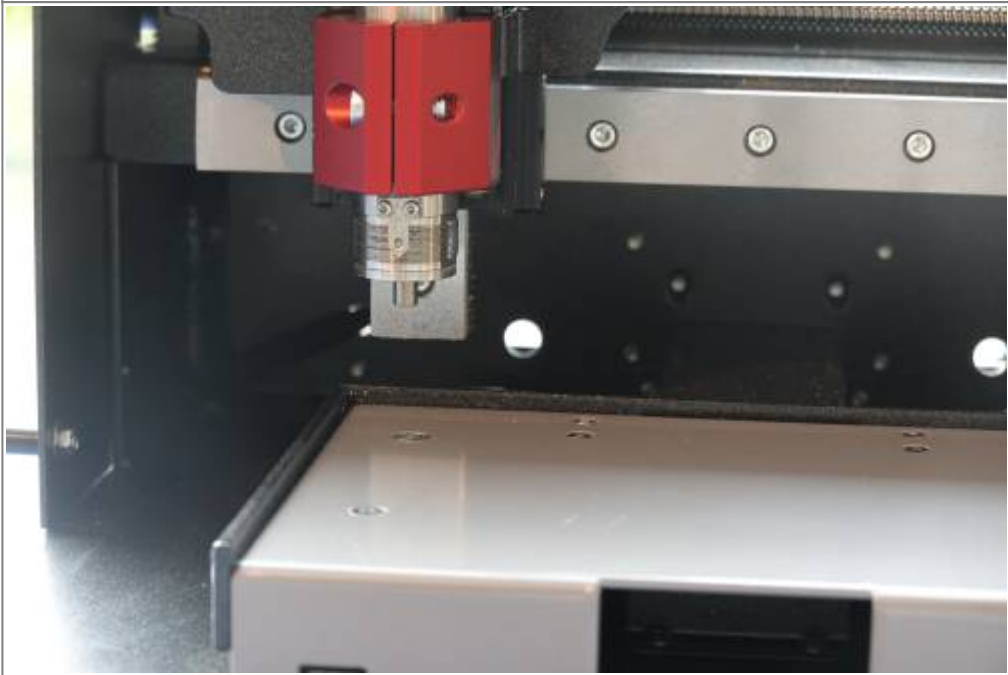
| Image | Description |
|---|---|
| | <p>Jog the spindle some distance away from the upper left corner, both in the X and the Y directions.</p> |

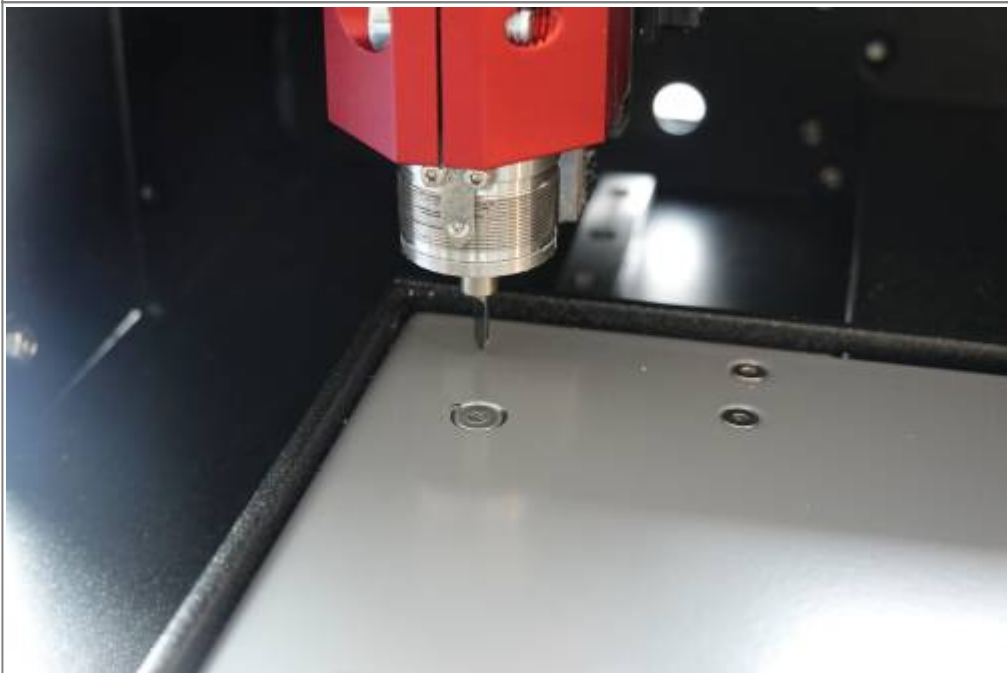
| Image | Description |
|---|---|
| | <p>Jog the Z-axis (the spindle) down till there is about 15 mm distance to the table surface.<br/>After that screw a cutter knob counter clockwise in the spindle.<br/>Then gently push a cutter through the cutter knob and the spindle. It has to stick out of the spindle at the bottom.<br/>Push the cutter through the spindle till its tip is as close as possible to the table surface, but without touching it.<br/>Tighten the cutter knob screw.</p> |

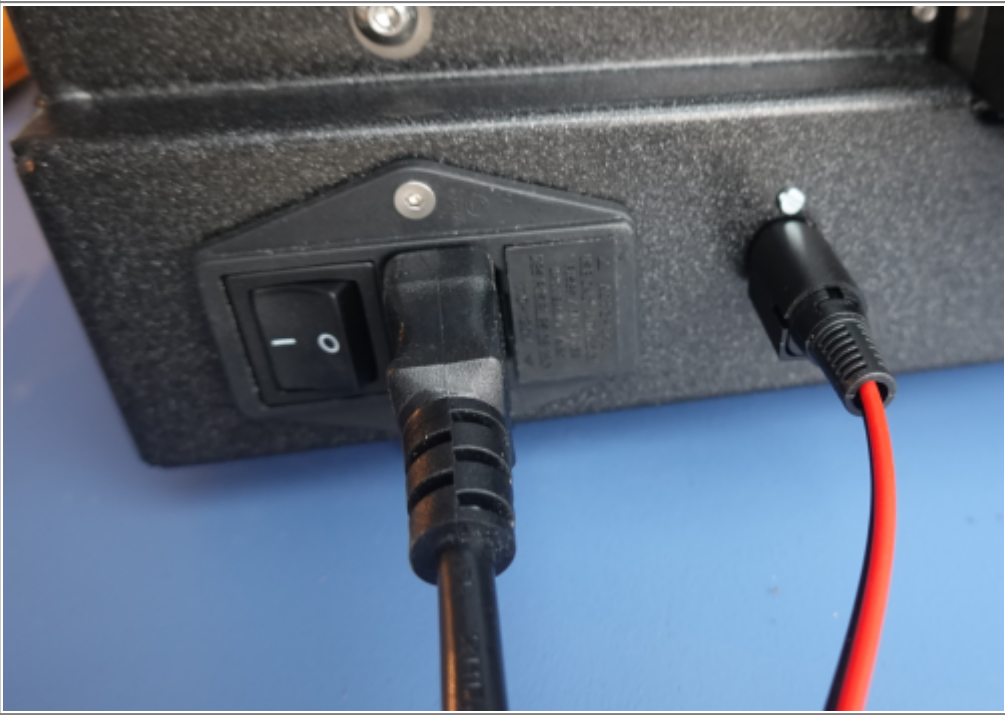
| Image | Description |
|---|---|
| A close-up photograph of the rear panel of a machine. It shows a black rocker switch in the 'off' position (marked with '0'). To the left of the switch, a black power cord is plugged into a port. To the right, a red cable is plugged into another port. The machine's body is dark grey or black. | <p>Switch off the machine using the mainswitch.</p> |

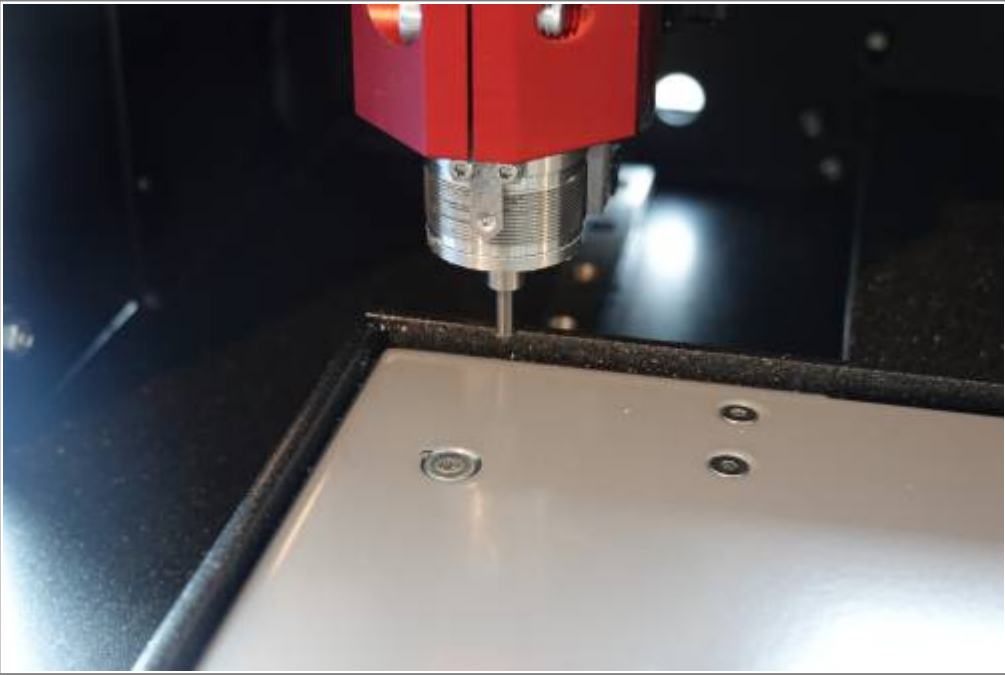
| Image | Description |
|---|---|
| A photograph showing the red and silver cutter head of a CNC machine. The silver spindle is lowered, and the cutting tool is positioned just above a light-colored, rectangular workpiece mounted on the machine bed. The background is dark. | <p>Gently rotate the black knob on the back side of the Y-axis stepper motor till the flat side of the cutter is well aligned with the rear table stop.</p> |

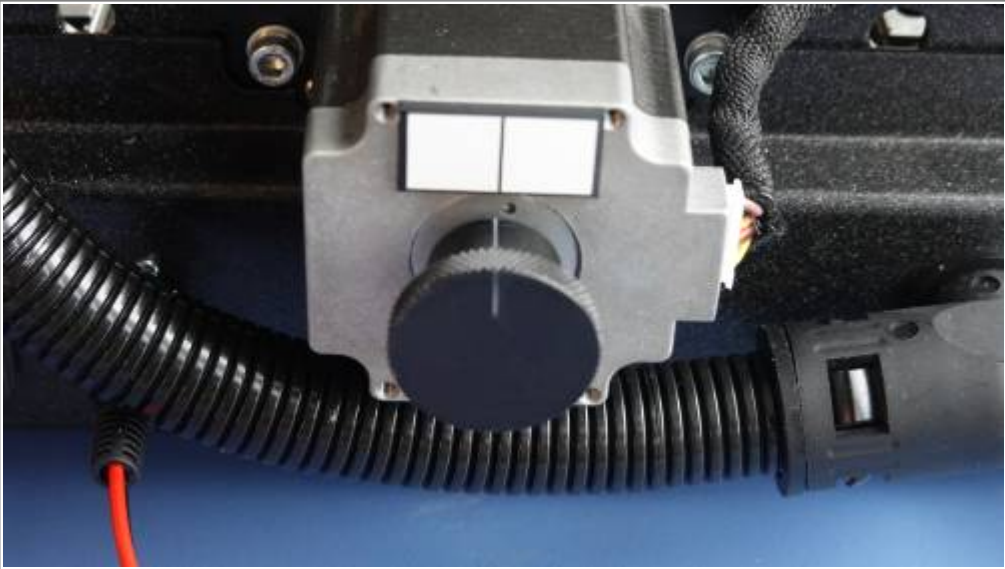
| Image | Description |
|---|---|
| A close-up photograph of a stepper motor assembly. A black, circular adjustment knob is visible on the front. A white rectangular label is attached to the top of the motor housing. A black braided cable is connected to the side. The background is dark. | <p>Now check if the finely engraved line on this knob corresponds with the engraved line on the indicator plate.<br/>If that is not the case, loosen the black knob and rotate it to properly align it with the engraved indicator plate.</p> |

| Image | Description |
|---|---|
| | Re-tighten this knob. |
