## The engraved data are not positioned correctly on the plate.

### To re-calibrate the X-axis home position, proceed as follows

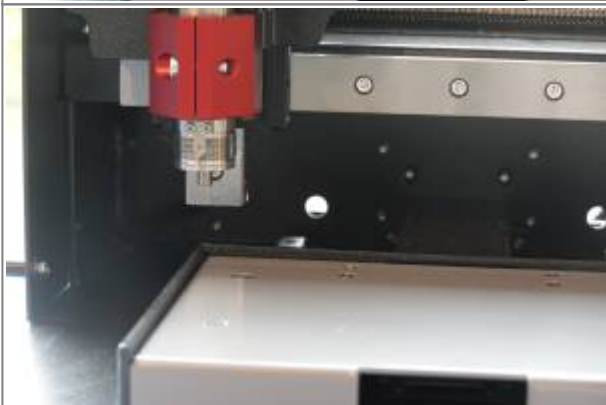
| Image | Description |
|---|---|
| | Remove the depth regulator nose from the spindle. |

- \* If there is an engraving plate and/or a Multimat on the engraving table, remove them.
- \* Remove the depth regulator nose from the spindle.
- \* Jog the spindle some distance away from the upper left corner, both in the X and the Y directions.
