## The engraved data are not positioned correctly on the plate.

### To re-calibrate the X-axis home position, proceed as follows

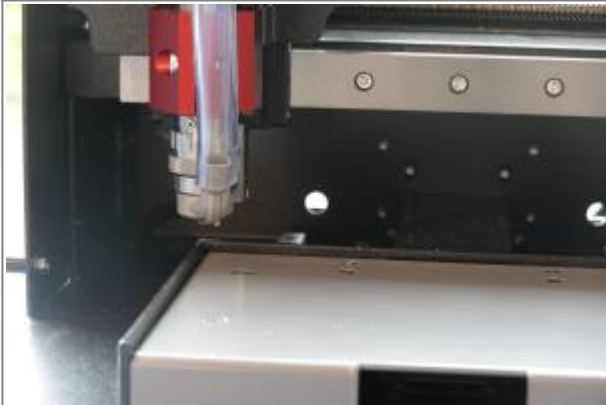
| Image | Description |
|---|---|
| | If there is an engraving plate and/or a Multimat on the engraving table, remove them. |

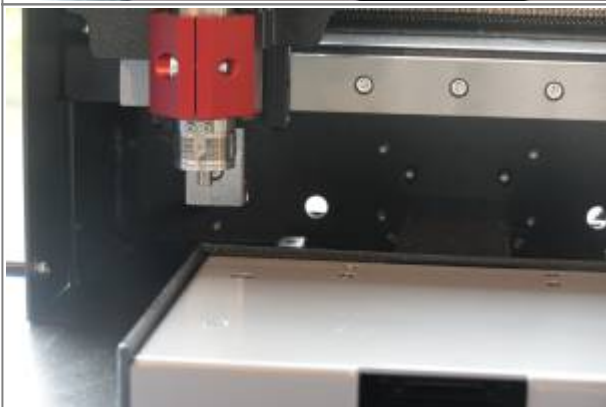
| Image | Description |
|---|---|
| | Remove the depth regulator nose from the spindle. |

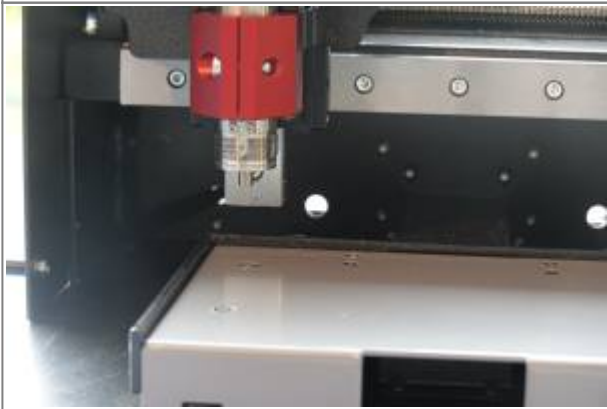
| Image | Description |
|---|---|
| | Jog the spindle some distance away from the upper left corner, both in the X and the Y directions. |

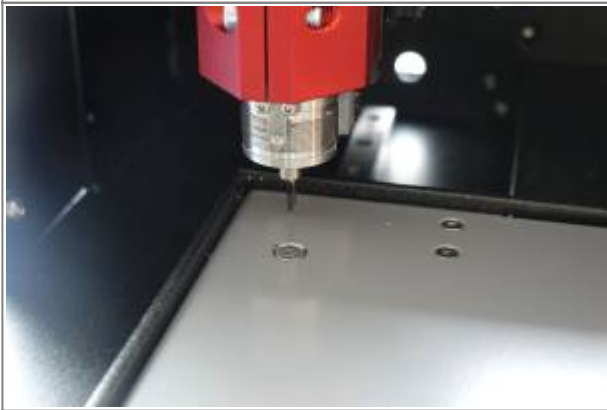
| Image | Description |
|---|---|
| | Jog the Z-axis (the spindle) down till there is about 15 mm distance to the table surface. |
