## The engraved data are not positioned correctly on the plate.

### To re-calibrate the X-axis home position, proceed as follows

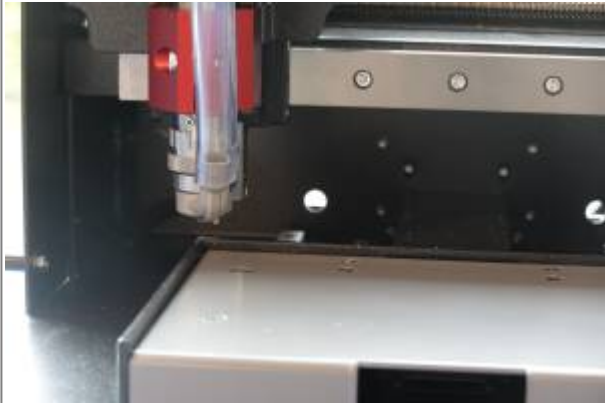
| Image | Description |
|---|---|
| | If there is an engraving plate and/or a Multimat on the engraving table, remove them. |

- \* If there is an engraving plate and/or a Multimat on the engraving table, remove them.
- \* Remove the depth regulator nose from the spindle.
- \* Jog the spindle some distance away from the upper left corner, both in the X and the Y directions.

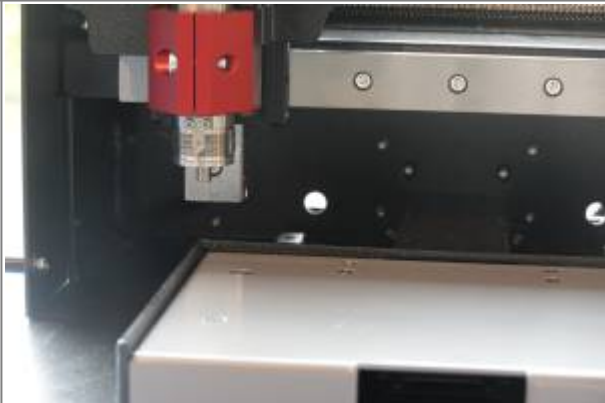
| Image | Description |
|---|---|
| | Remove the depth regulator nose from the spindle. |

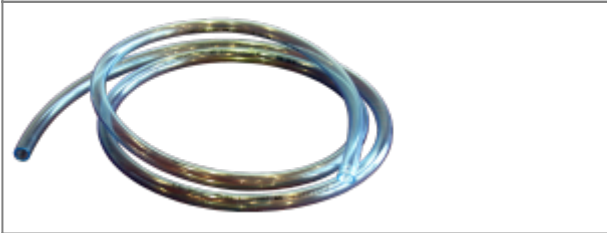
| Image | Description |
|---|---|
| | Switch off the machine using the mainswitch. |

- \* Jog the Z-axis (the spindle) down till there is about 15 mm distance to the table surface.
- \* Switch off the machine using the mainswitch.
- \* Put an engraving cutter in the spindle. It will be sticking out of the spindle at the bottom.

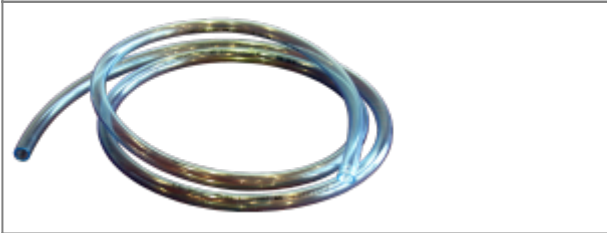
| Image | Description |
|---|---|
| | Gently rotate the black knob on the back side of the X-axis stepper motor till the flat side of the cutter is well aligned with the left table stop. |

- \* Gently rotate the black knob on the back side of the Y-axis stepper motor till the flat side of the cutter is well aligned with the top table stop.

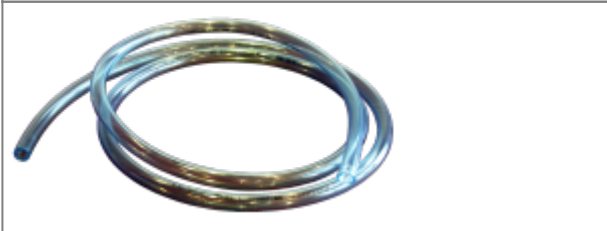
| Image | Description |
|---|---|
| | Now check if the finely engraved line on this knob corresponds with the engraved line on the indicator plate. If that is not the case, loosen the black knob and rotate it to properly align it with the engraved indicator plate. |

- \* Now check if the finely engraved line on this knob corresponds with the engraved line on the indicator plate. If that is not the case, loosen the black knob and rotate it to properly align it with the engraved indicator plate.

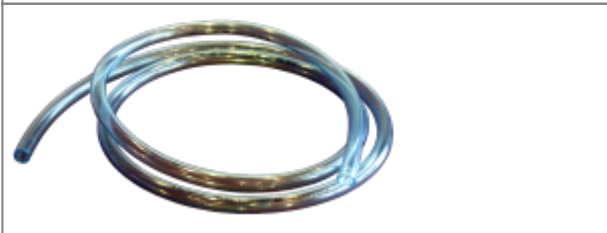
| Image | Description |
|---|---|
| | Re-tighten this knob. |

- \* Re-tighten this knob.
