## The engraved data are not positioned correctly on the plate.

### To re-calibrate the X-axis home position, proceed as follows

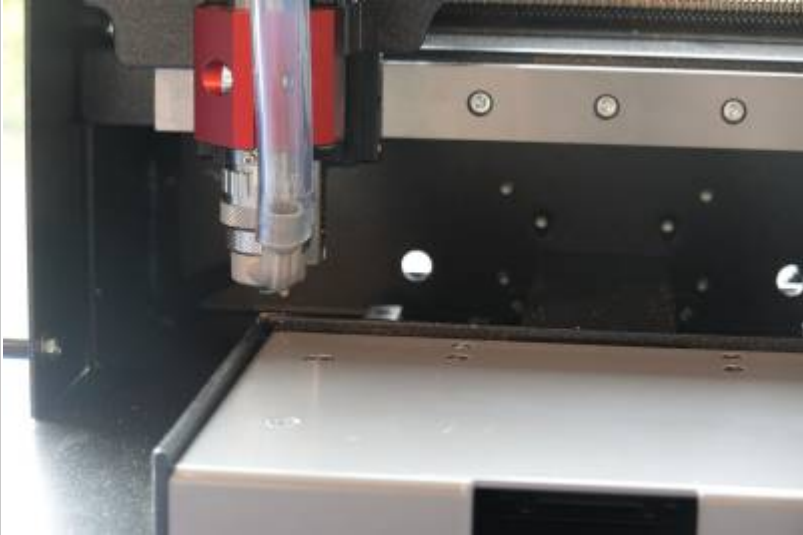
| Image | Description |
|---|---|
| | If there is an engraving plate and/or a Multimat on the engraving table, remove them. |

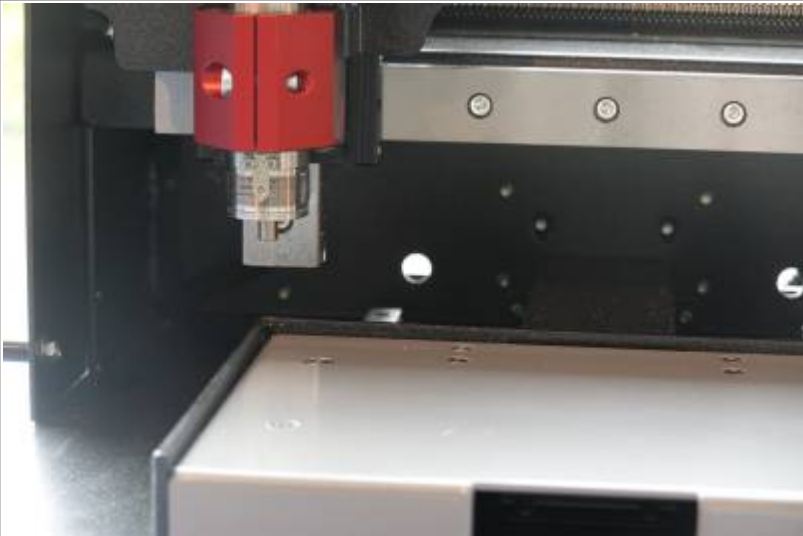
| Image | Description |
|---|---|
| | Remove the depth regulator nose from the spindle. |

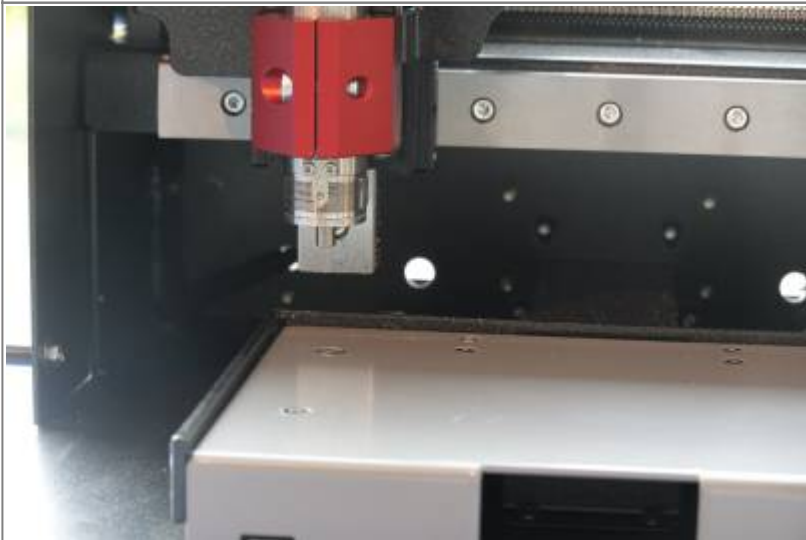
| Image | Description |
|---|---|
| | <p>Jog the spindle some distance away from the upper left corner, both in the X and the Y directions.</p> |

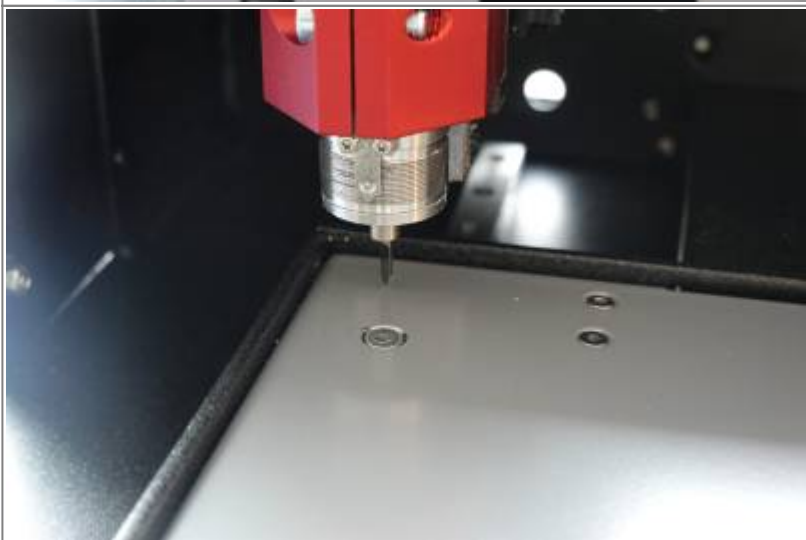
| Image | Description |
|---|---|
| | <p>Jog the Z-axis (the spindle) down till there is about 15 mm distance to the table surface.<br/> After that put an engraving cutter in the spindle.<br/> It will be sticking out of the spindle at the bottom.<br/> Loosen the cutter knob screw and push the cutter through the spindle till its tip is as close as possible to the table surface, but without touching it.</p> |
