## The engraved data are not positioned correctly on the plate.

### To re-calibrate the X-axis home position, proceed as follows

**To re-calibrate the Y-axis home position the procedure to follow is the same:**

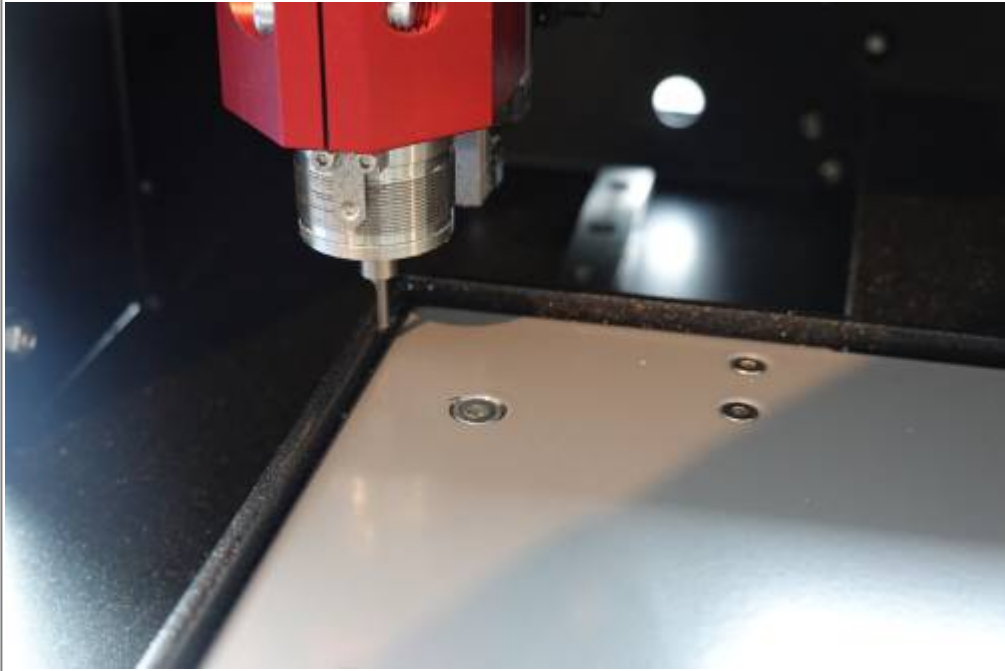
| Image | Description |
|---|---|
| | Gently rotate the black knob on the back side of the X-axis stepper motor till the flat side of the cutter is well aligned with the left table stop. |

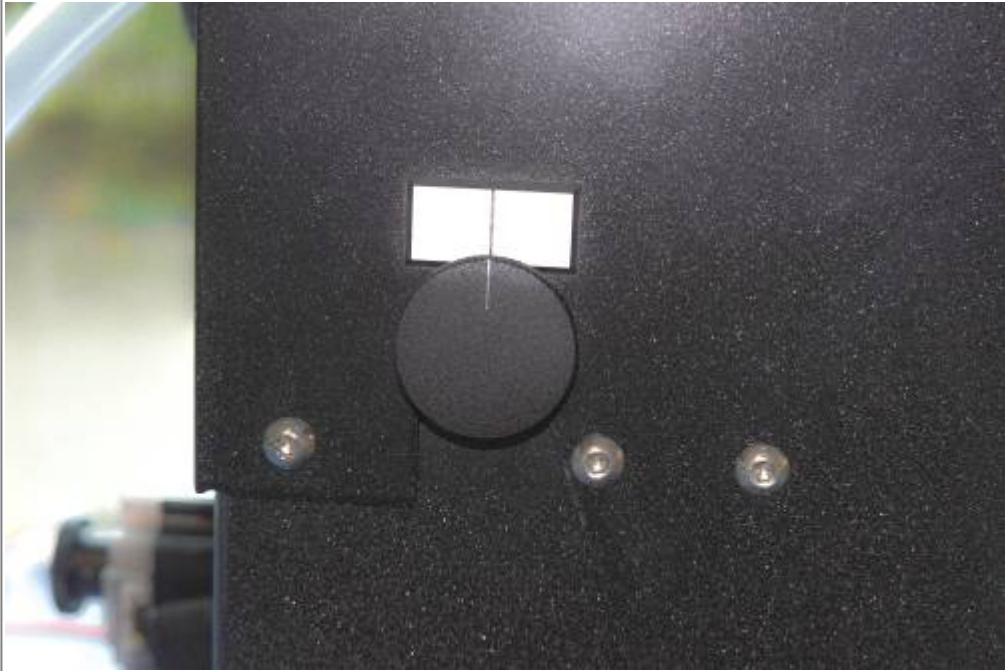
| Image | Description |
|---|---|
| | Now check if the finely engraved line on this knob corresponds with the engraved line on the indicator plate.<br>If that is not the case, loosen the black knob and rotate it to properly align it with the engraved indicator plate. |
| | Re-tighten this knob. |

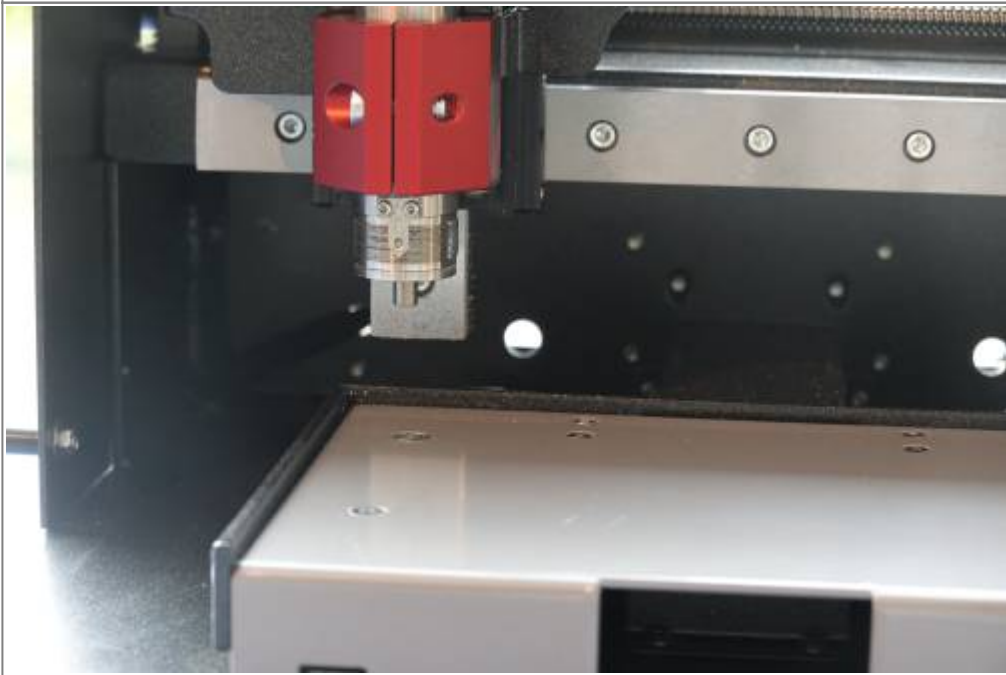
| Image | Description |
|---|---|
| | <p>Jog the spindle some distance away from the upper left corner, both in the X and the Y directions.</p> |

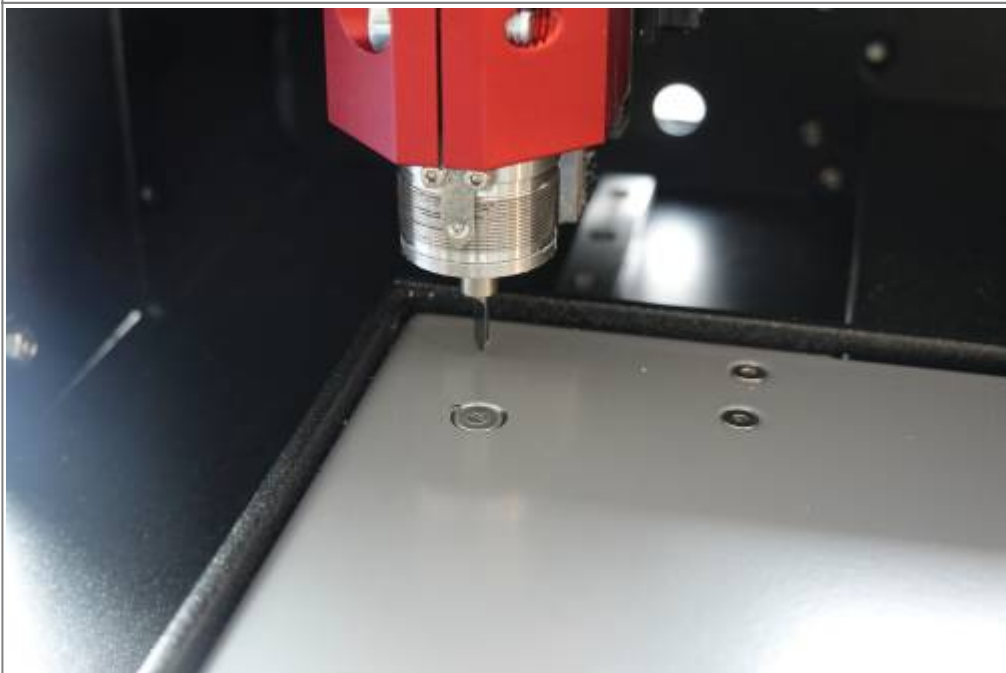
| Image | Description |
|---|---|
| | <p>Jog the Z-axis (the spindle) down till there is about 15 mm distance to the table surface.<br/>After that screw a cutter knob counter clockwise in the spindle.<br/>Then gently push a cutter through the cutter knob and the spindle. It has to stick out of the spindle at the bottom.<br/>Push the cutter through the spindle till its tip is as close as possible to the table surface, but without touching it.<br/>Tighten the cutter knob screw.</p> |

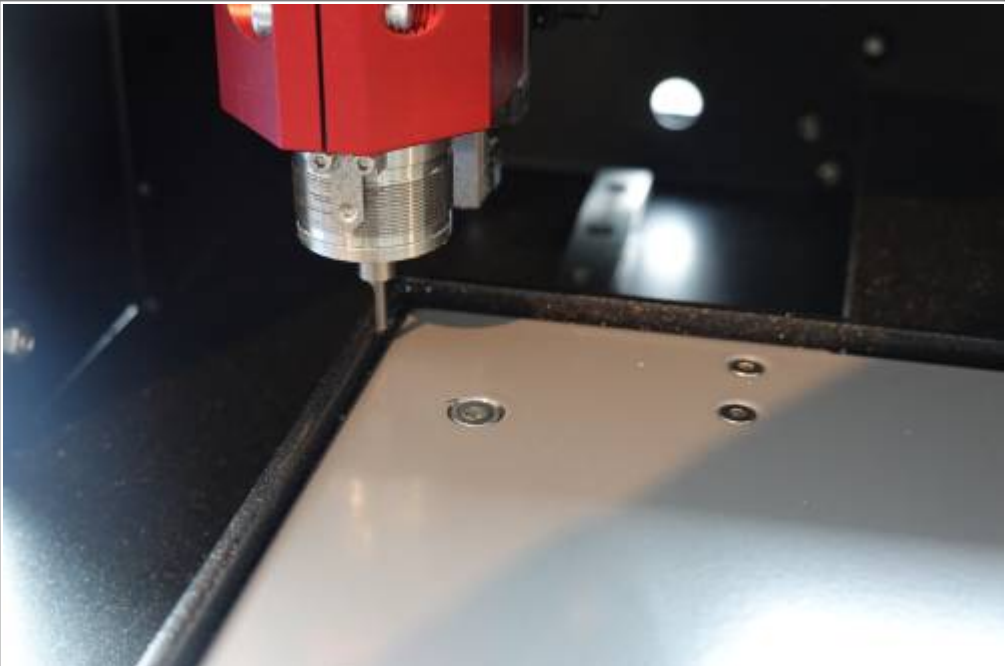
| Image | Description |
|---|---|
| A close-up photograph of the machine's cutting head, which is red and silver. The head is positioned over a white table. The cutting head is shown in a vertical position, ready to cut. | <p>Gently rotate the black knob on the back side of the Y-axis stepper motor till the flat side of the cutter is well aligned with the rear table stop.</p> |

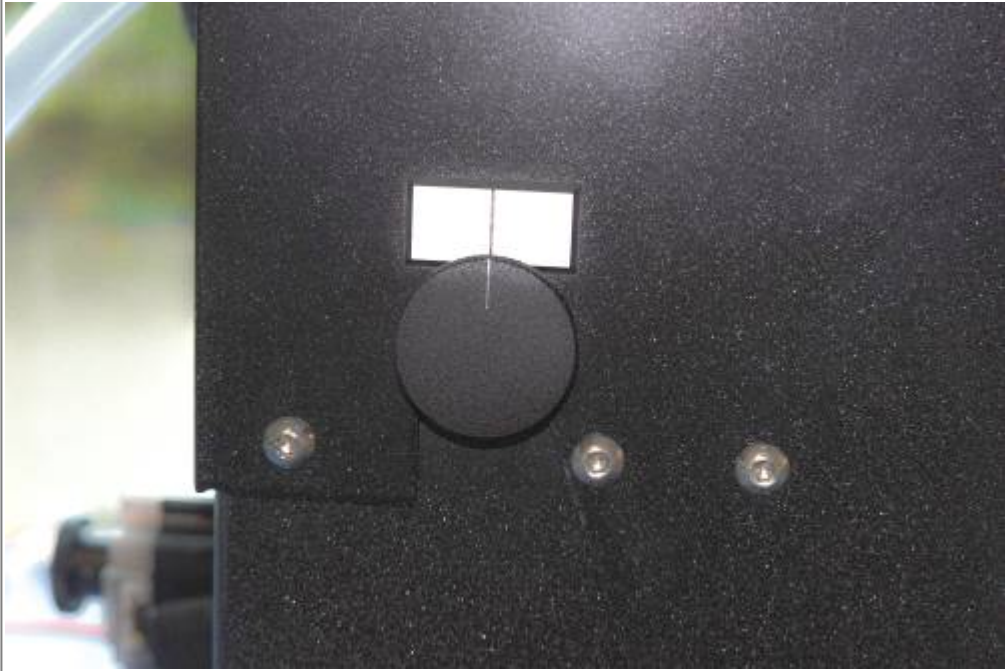
| Image | Description |
|---|---|
| | <p>Now check if the finely engraved line on this knob corresponds with the engraved line on the indicator plate.<br/>If that is not the case, loosen the black knob and rotate it to properly align it with the engraved indicator plate.</p> |
| | Re-tighten this knob. |
