## The engraved data are not positioned correctly on the plate.

### To re-calibrate the X-axis home position, proceed as follows

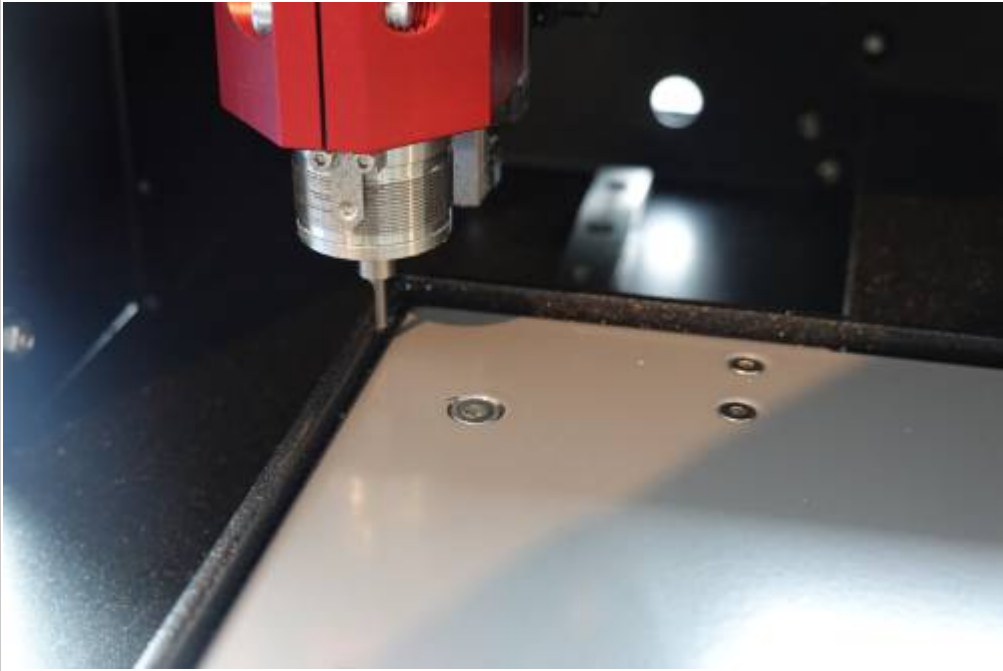
| Image | Description |
|---|---|
| | Gently rotate the black knob on the back side of the X-axis stepper motor till the flat side of the cutter is well aligned with the left table stop. |

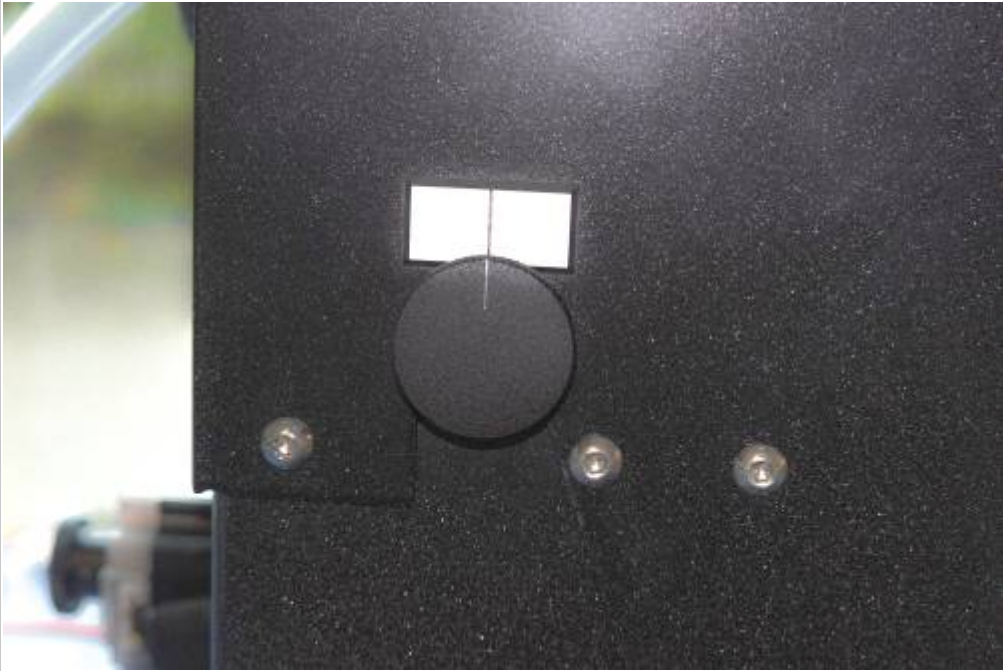
| Image | Description |
|---|---|
| | Now check if the finely engraved line on this knob corresponds with the engraved line on the indicator plate.<br>If that is not the case, loosen the black knob and rotate it to properly align it with the engraved indicator plate. |
| | Re-tighten this knob. |

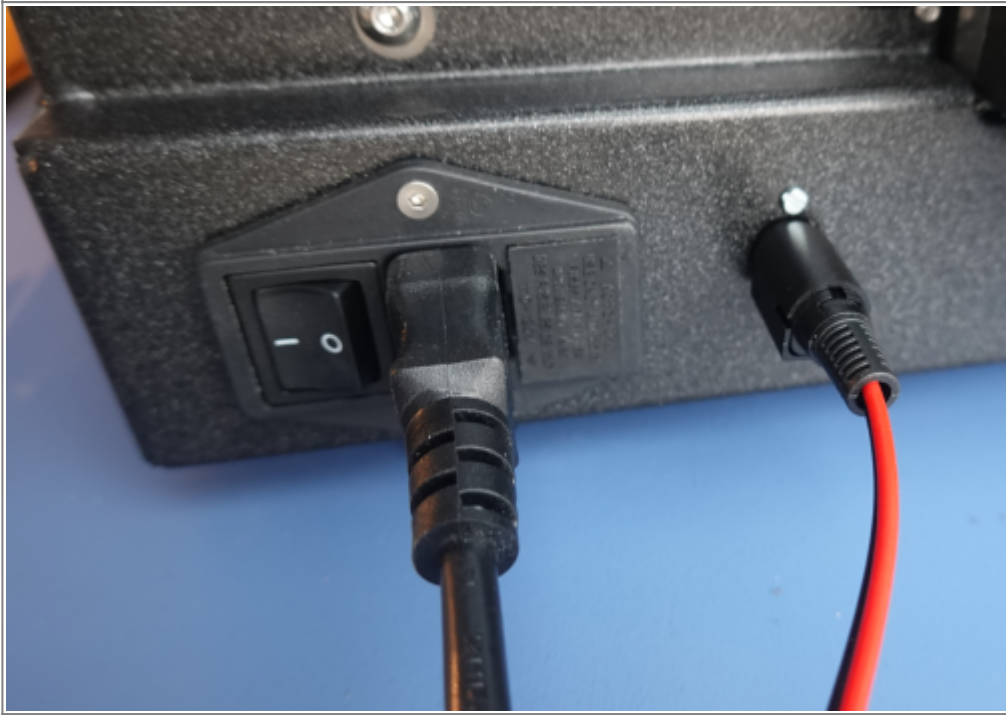
| Image | Description |
|---|---|
| A close-up photograph of the machine's main power switch, which is a black rocker switch with 'I' and 'O' markings. A black power cord is plugged into the switch, and a red cable is plugged into a nearby port. The machine's housing is black and textured. | <p>Switch off the machine using the mainswitch.</p> |

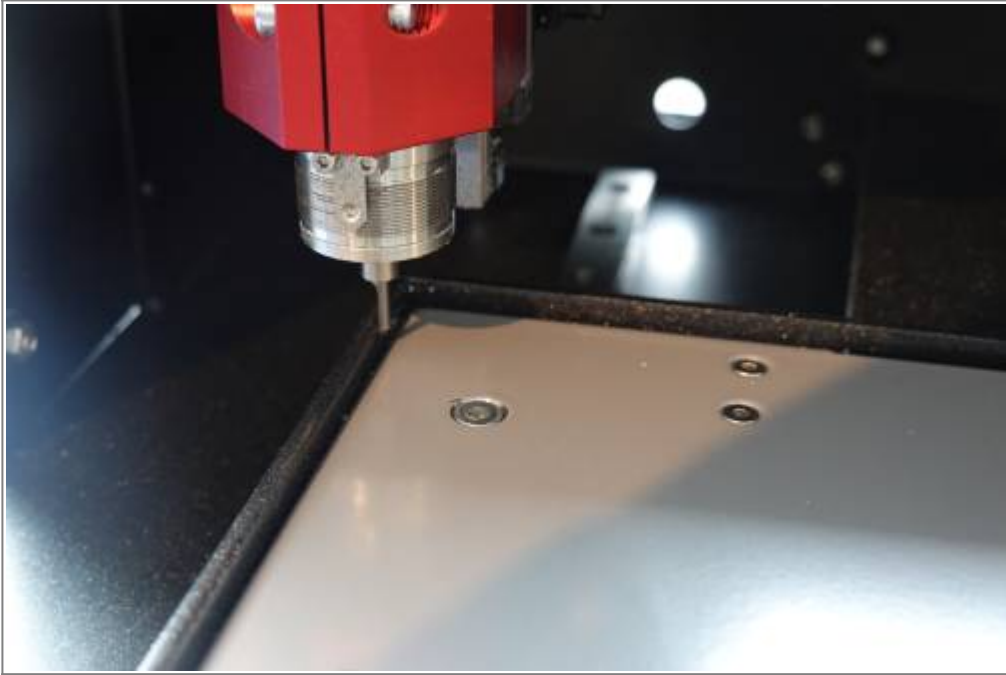
| Image | Description |
|---|---|
| A close-up photograph of the engraving head, which is red and silver, positioned above a white table. The head is lowered, and the engraving process is visible on the table surface. | <p>Gently rotate the black knob on the back side of the Y-axis stepper motor till the flat side of the cutter is well aligned with the rear table stop.</p> |

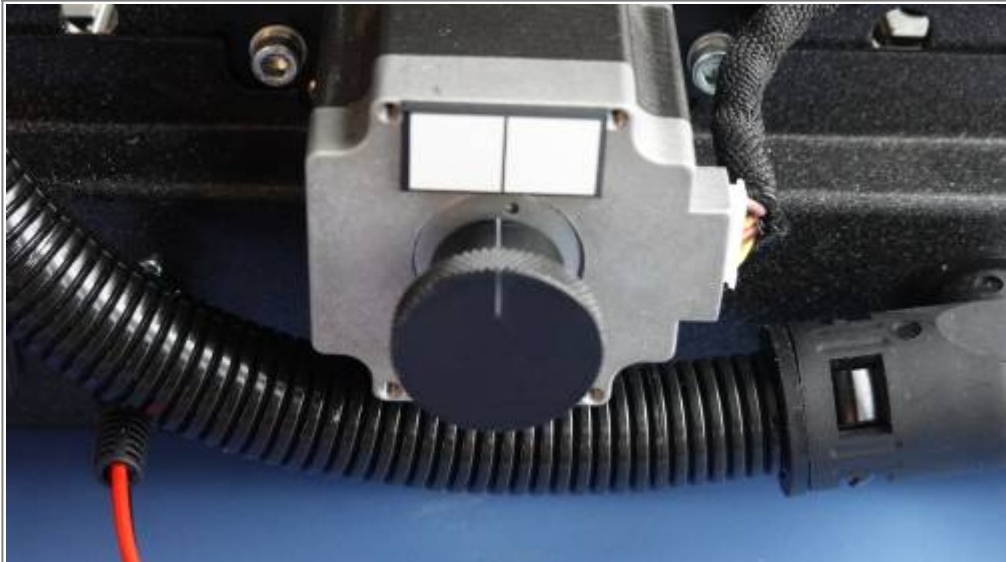
| Image | Description |
|---|---|
| A close-up photograph of the Y-axis stepper motor knob, which is a black, circular, textured knob. It is mounted on a silver metal plate. A black cable is connected to the motor. | <p>Now check if the finely engraved line on this knob corresponds with the engraved line on the indicator plate.<br/>If that is not the case, loosen the black knob and rotate it to properly align it with the engraved indicator plate.</p> |

| Image | Description |
|---|---|
| | Re-tighten this knob. |
