## The engraved data are not positioned correctly on the plate.

### To re-calibrate the X-axis home position, proceed as follows

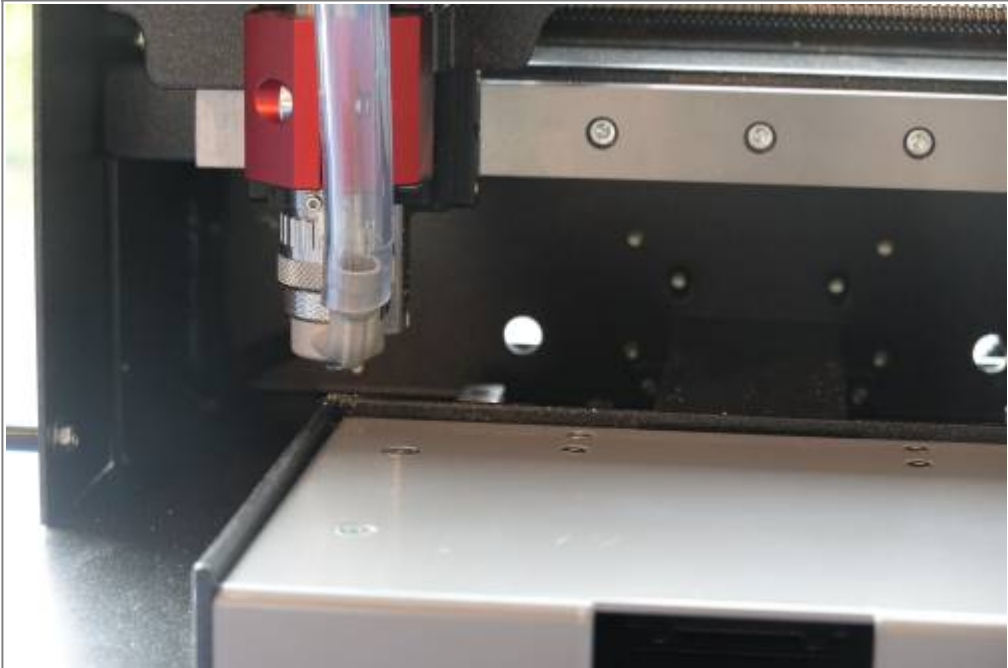
| Image | Description |
|---|---|
| | <p>If there is an engraving plate and/or a Multimat on the engraving table, remove them.</p> |

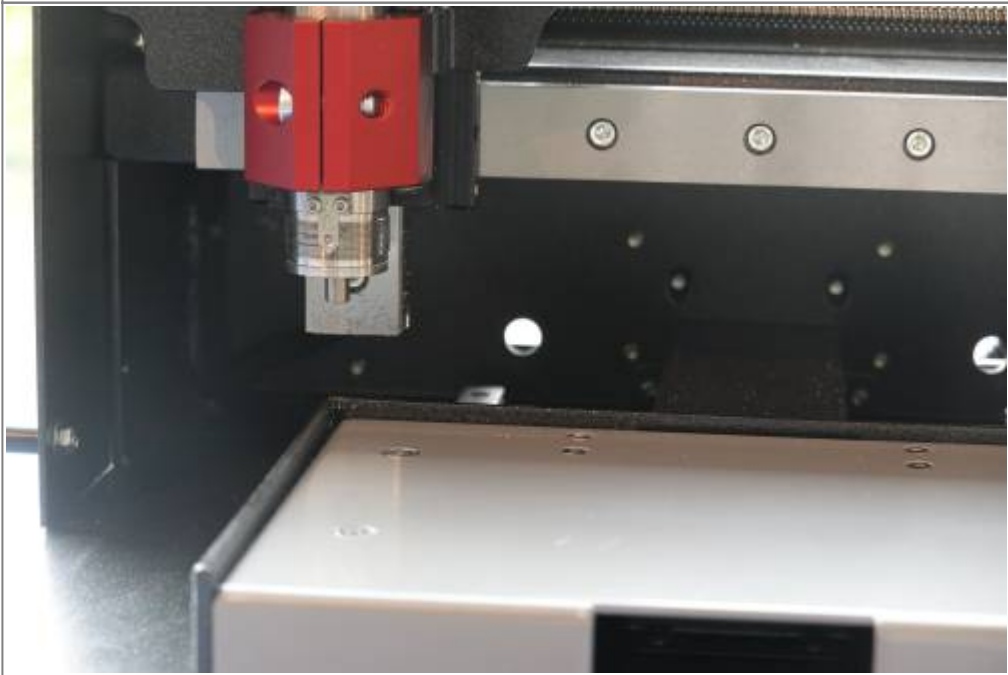
| Image | Description |
|---|---|
| | <p>Remove the depth regulator nose from the spindle.</p> |

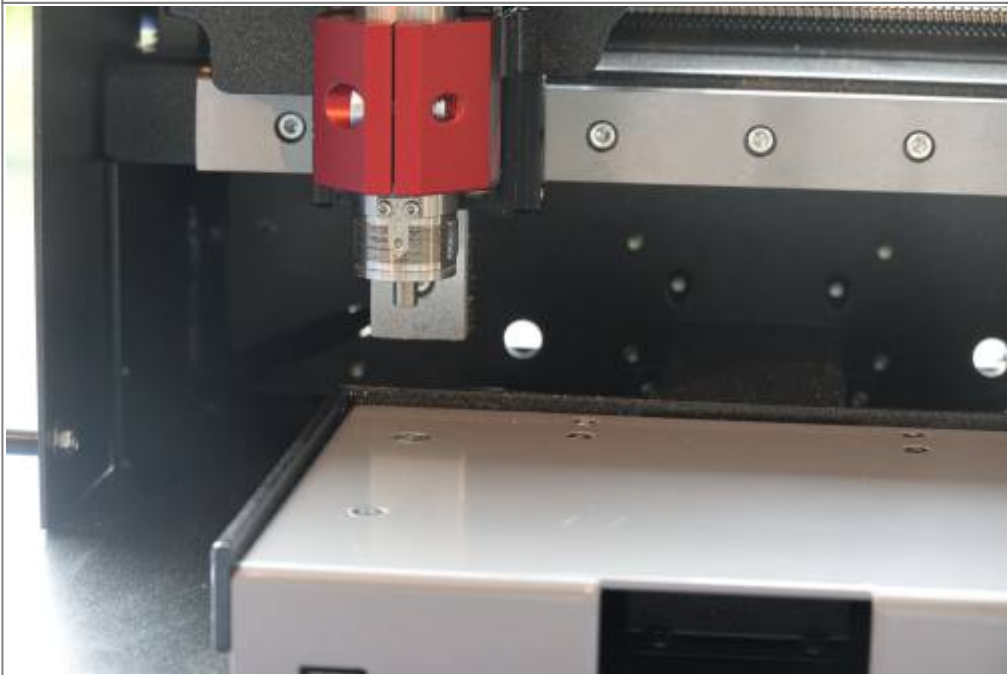
| Image | Description |
|---|---|
| | <p>Jog the spindle some distance away from the upper left corner, both in the X and the Y directions.</p> |

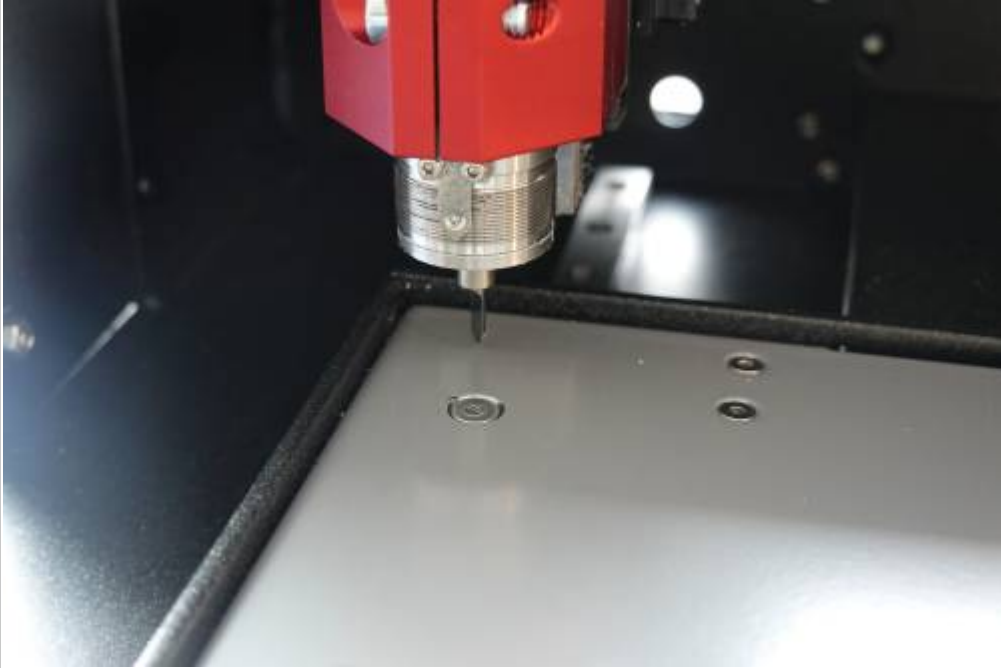
| Image | Description |
|---|---|
| | <p>Jog the Z-axis (the spindle) down till there is about 15 mm distance to the table surface.</p> <p>After that screw a cutter knob counter clockwise in the spindle.</p> <p>Then gently push a cutter through the cutter knob and the spindle. It has to stick out of the spindle at the bottom.</p> <p>Push the cutter through the spindle till its tip is as close as possible to the table surface, but without touching it.</p> <p>Tighten the cutter knob screw.</p> |

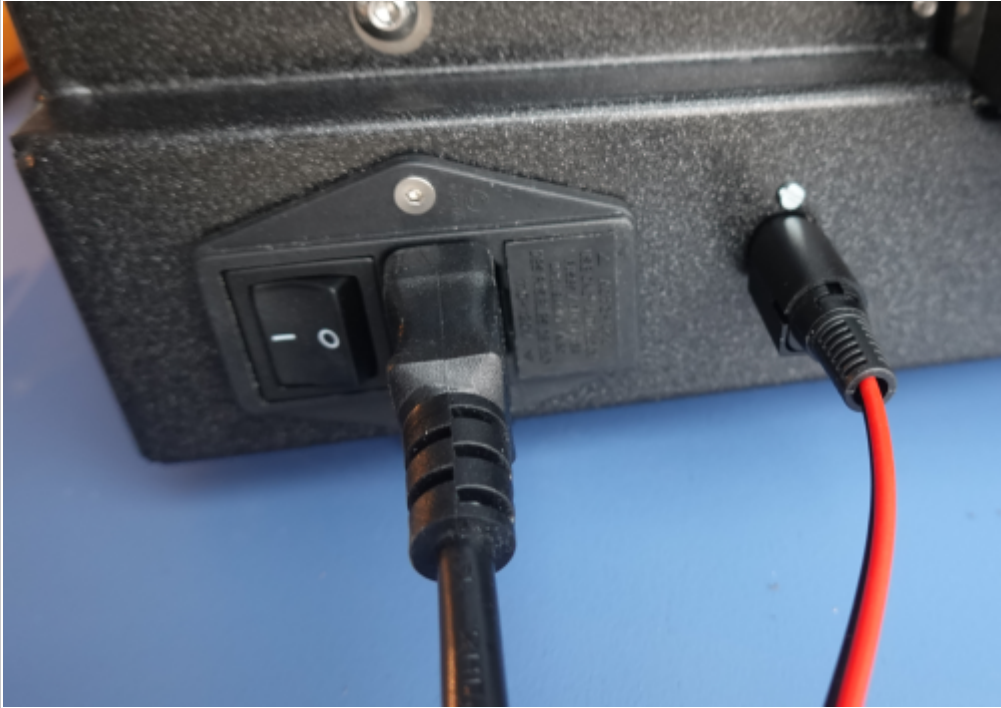
| Image | Description |
|---|---|
| | <p>Switch off the machine using the mains switch.</p> |

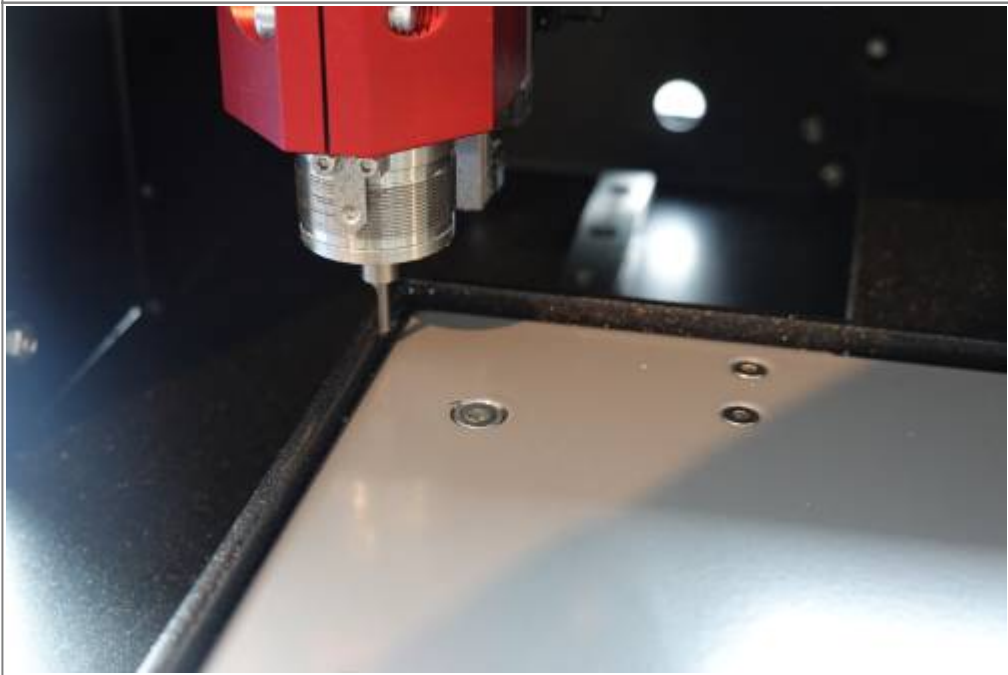
| Image | Description |
|---|---|
| | <p>Gently rotate the black knob on the back side of the X-axis stepper motor till the flat side of the cutter is well aligned with the left table stop.</p> |

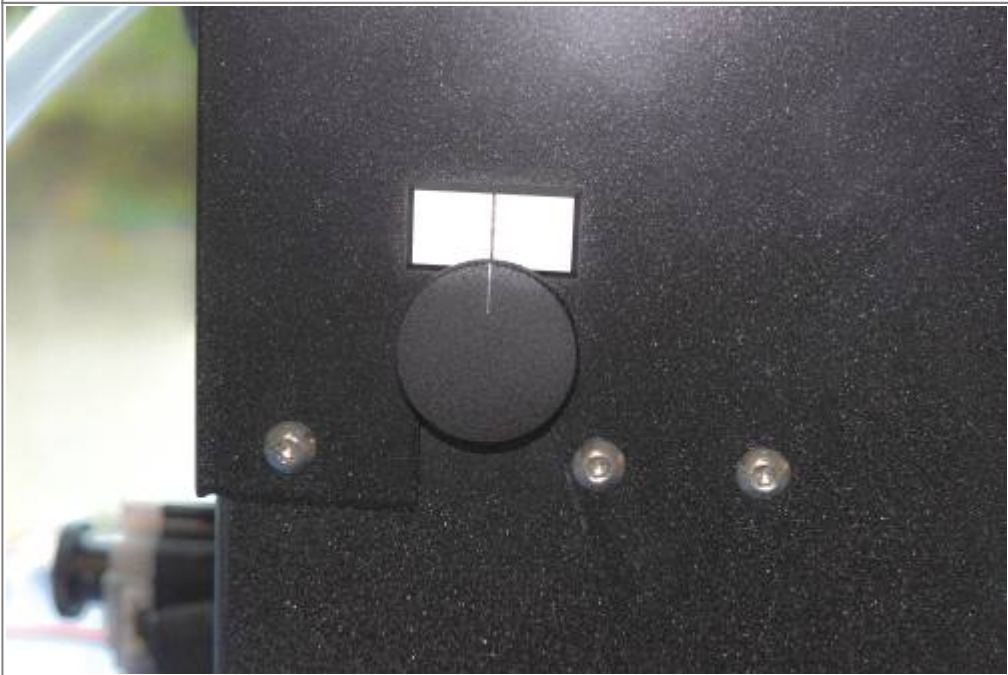
| Image | Description |
|---|---|
| | <p>Now check if the finely engraved line on this knob corresponds with the engraved line on the indicator plate.<br/>If that is not the case, loosen the black knob and rotate it to properly align it with the engraved indicator plate.</p> |
| | <p>Re-tighten this knob.</p> |

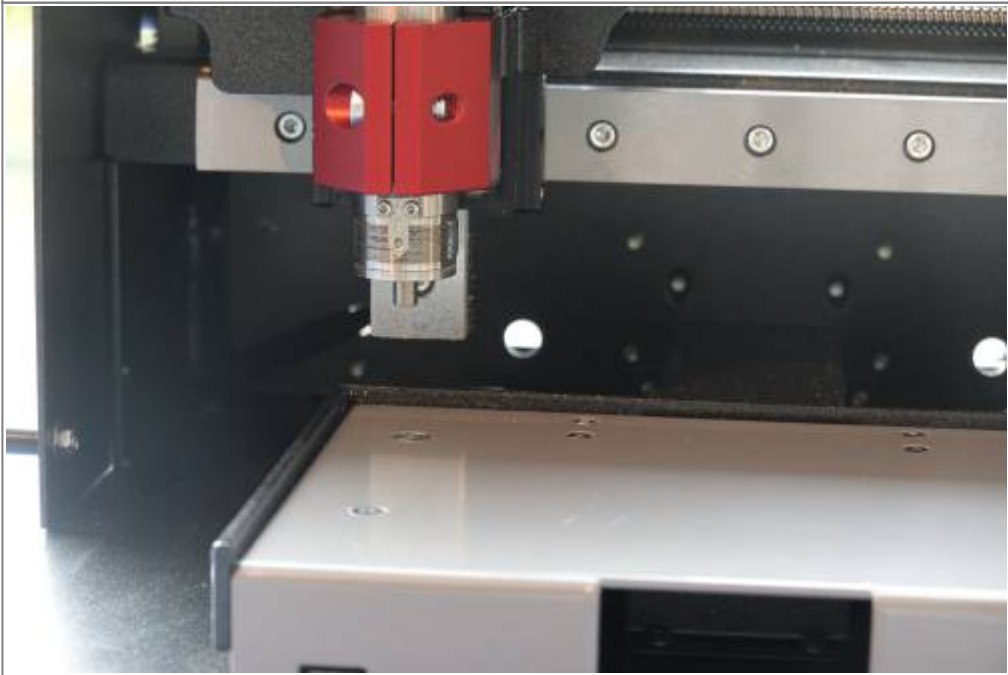
| Image | Description |
|---|---|
| | <p>Jog the spindle some distance away from the upper left corner, both in the X and the Y directions.</p> |

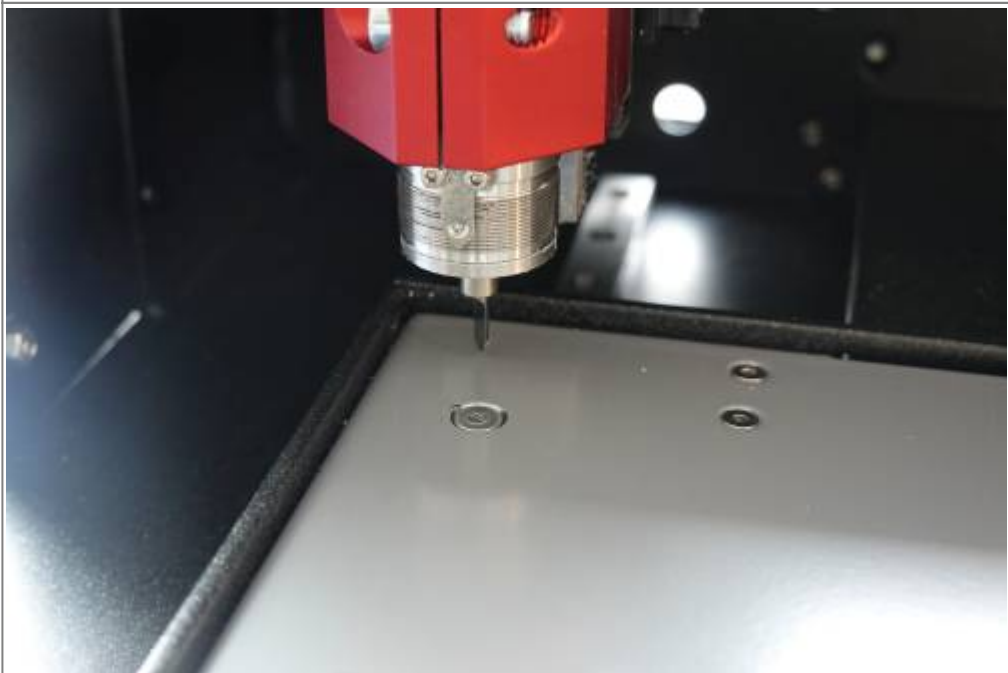
| Image | Description |
|---|---|
| | <p>Jog the Z-axis (the spindle) down till there is about 15 mm distance to the table surface.<br/>After that screw a cutter knob counter clockwise in the spindle.<br/>Then gently push a cutter through the cutter knob and the spindle. It has to stick out of the spindle at the bottom.<br/>Push the cutter through the spindle till its tip is as close as possible to the table surface, but without touching it.<br/>Tighten the cutter knob screw.</p> |

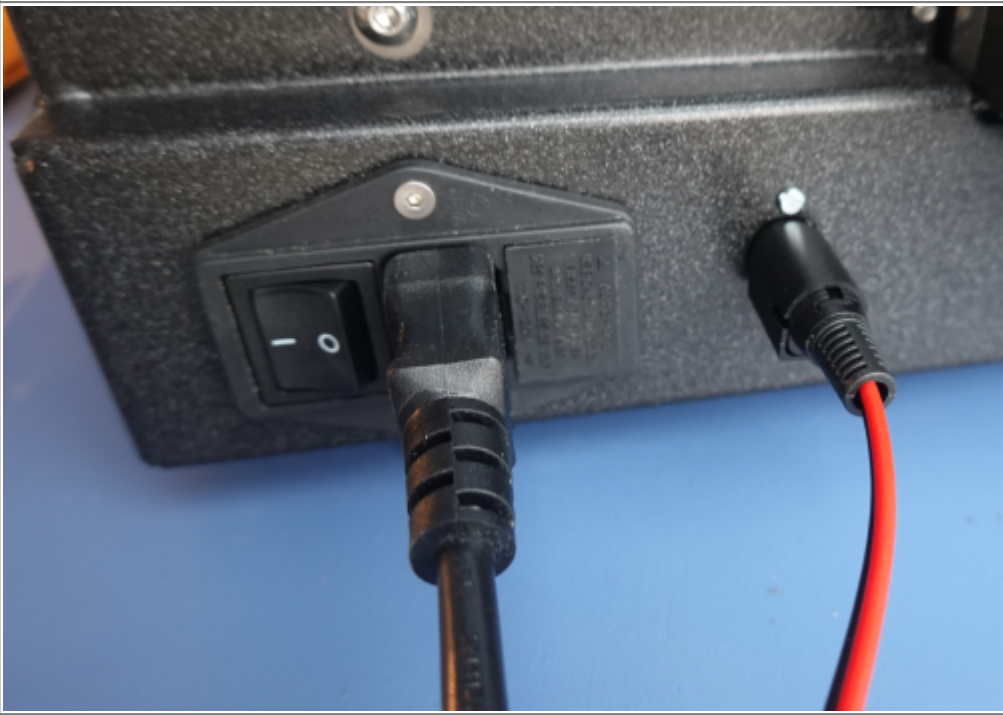
| Image | Description |
|---|---|
| | <p>Switch off the machine using the mainswitch.</p> |

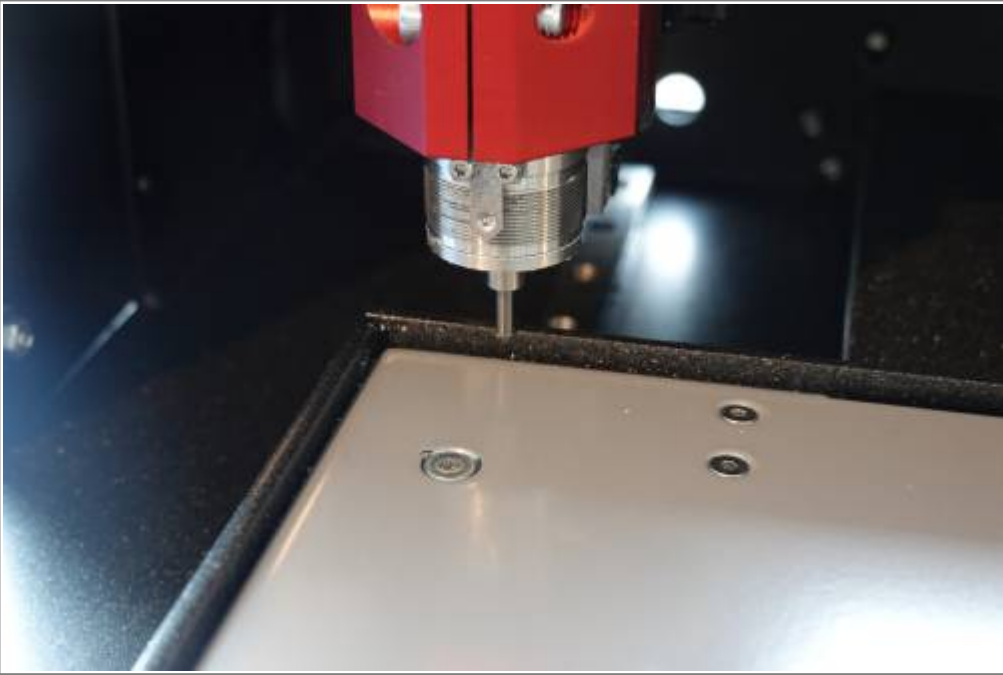
| Image | Description |
|---|---|
| | <p>Gently rotate the black knob on the back side of the Y-axis stepper motor till the flat side of the cutter is well aligned with the rear table stop.</p> |

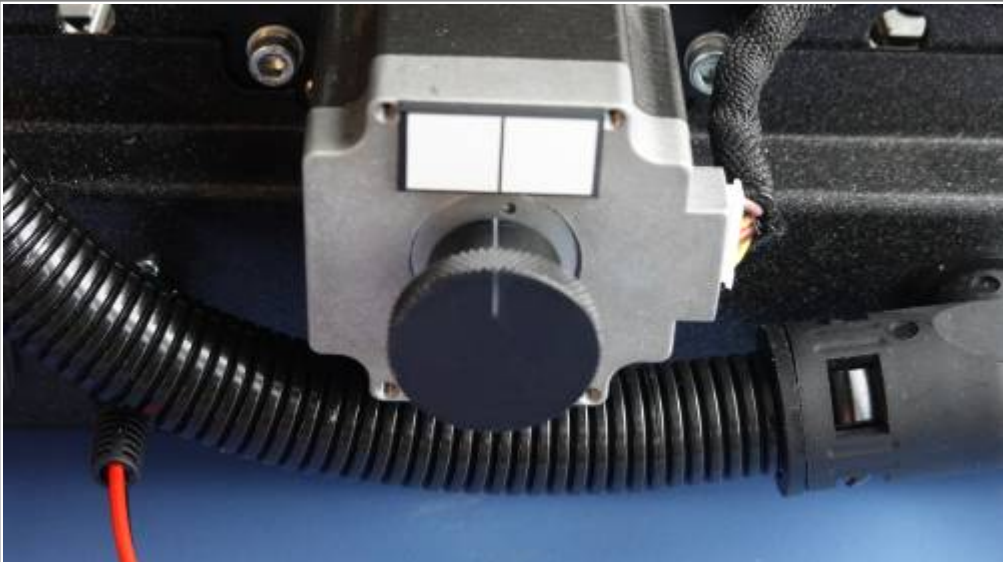
| Image | Description |
|---|---|
| | <p>Now check if the finely engraved line on this knob corresponds with the engraved line on the indicator plate.<br/>If that is not the case, loosen the black knob and rotate it to properly align it with the engraved indicator plate.</p> |

| Image | Description |
|---|---|
| | Re-tighten this knob. |
