## The engraved data are not positioned correctly on the plate.

### To re-calibrate the X-axis home position, proceed as follows

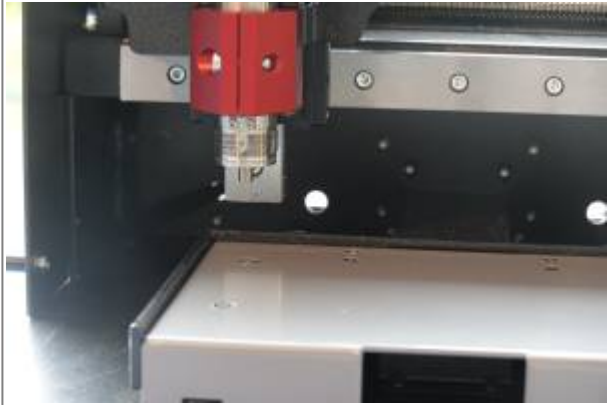
| Image | Description |
|---|---|
| | Jog the spindle some distance away from the upper left corner, both in the X and the Y directions. |

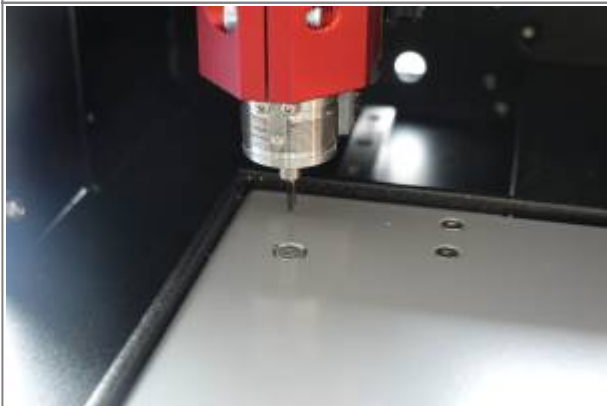
| Image | Description |
|---|---|
| | Jog the Z-axis (the spindle) down till there is about 15 mm distance to the table surface and put an engraving cutter in the spindle. It will be sticking out of the spindle at the bottom.<br>Loosen the cutter knob and push the cutter through the spindle till its tip is as close as possible to the table surface, but without touching it. |
