## The engraved data are not positioned correctly on the plate.

### To re-calibrate the X-axis home position, proceed as follows

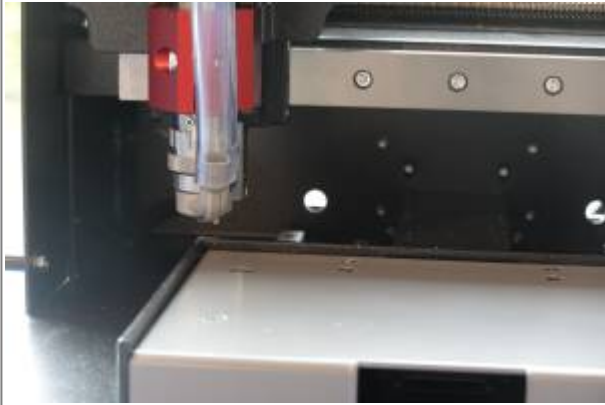
| Image | Description |
|---|---|
| | If there is an engraving plate and/or a Multimat on the engraving table, remove them. |

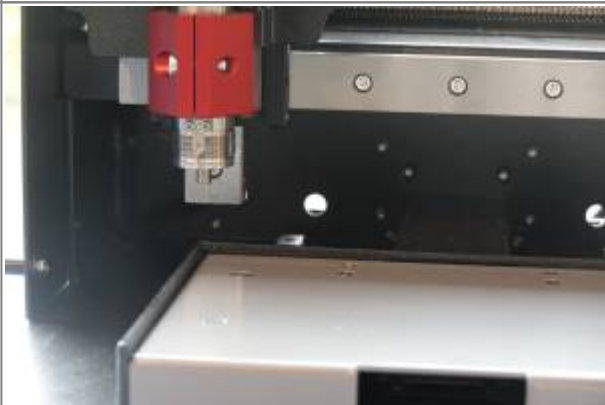
| Image | Description |
|---|---|
| | Remove the depth regulator nose from the spindle. |

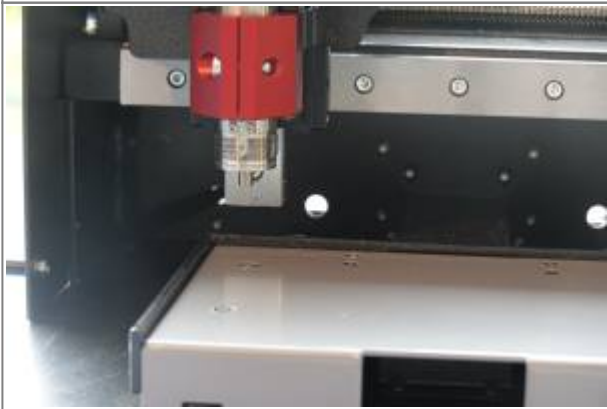
| Image | Description |
|---|---|
| | Jog the spindle some distance away from the upper left corner, both in the X and the Y directions. |

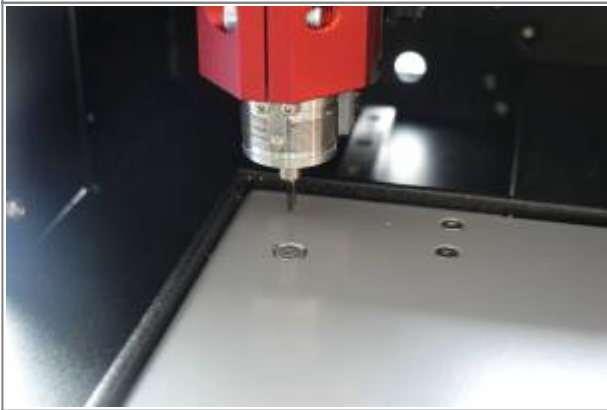
| Image | Description |
|---|---|
| | Jog the Z-axis (the spindle) down till there is about 15 mm distance to the table surface.<br>After that put an engraving cutter in the spindle. It will be sticking out of the spindle at the bottom. Loosen the cutter knob screw and push the cutter through the spindle till its tip is as close as possible to the table surface, but without touching it. |
