## The engraved data are not positioned correctly on the plate.

### To re-calibrate the X-axis home position, proceed as follows

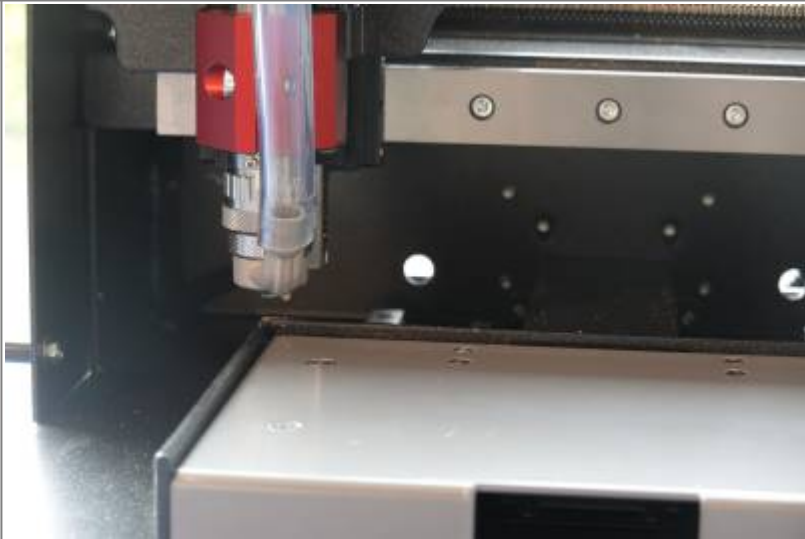
| Image | Description |
|---|---|
| | If there is an engraving plate and/or a Multimat on the engraving table, remove them. |

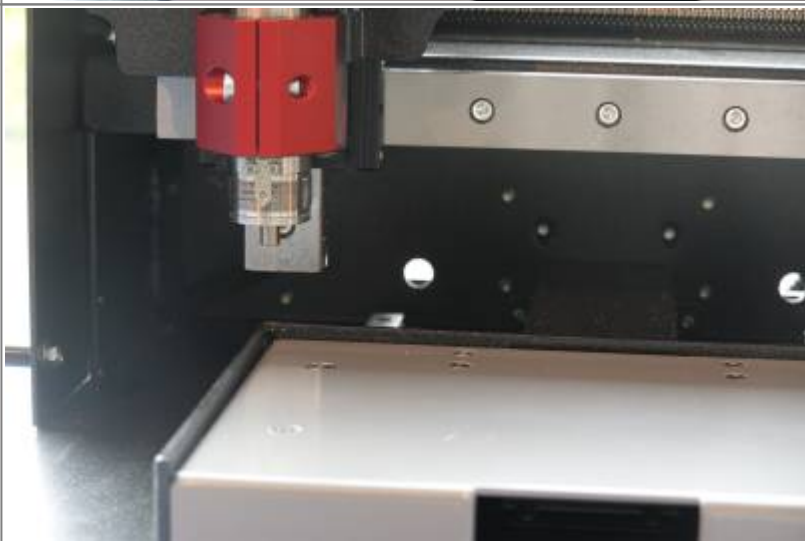
| Image | Description |
|---|---|
| | Remove the depth regulator nose from the spindle. |

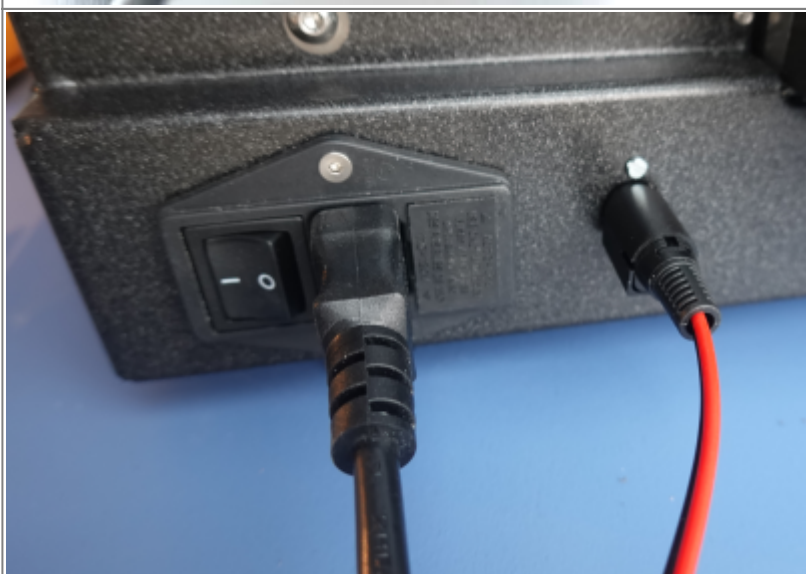
| Image | Description |
|---|---|
| | <p>Switch off the machine using the mains switch.</p> |
