## The engraved data are not positioned correctly on the plate.

### To re-calibrate the X-axis home position, proceed as follows

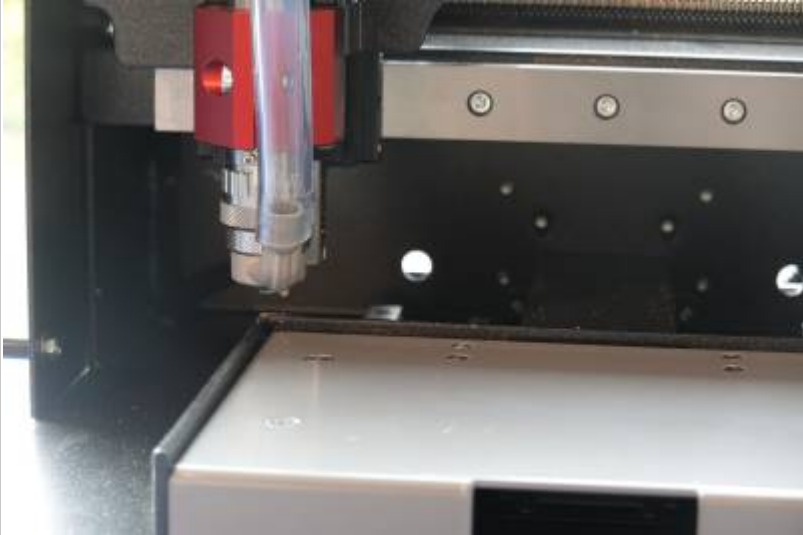
| Image | Description |
|---|---|
| | If there is an engraving plate and/or a Multimat on the engraving table, remove them. |

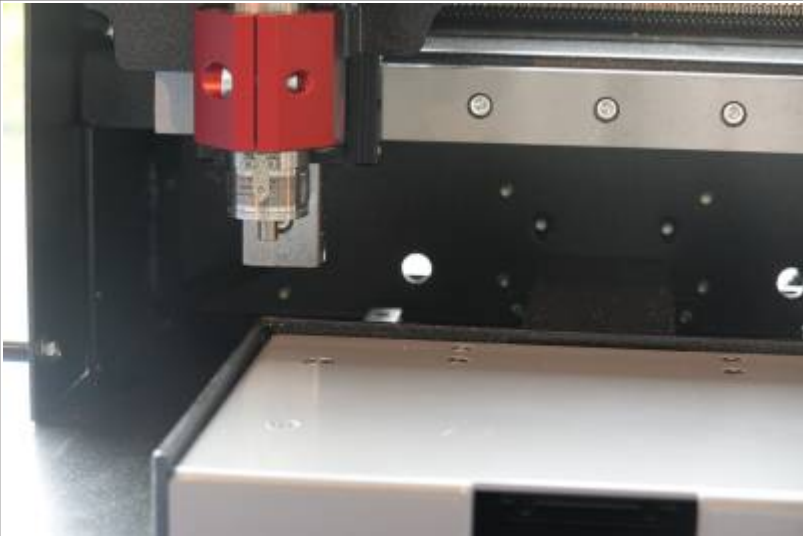
| Image | Description |
|---|---|
| | Remove the depth regulator nose from the spindle. |

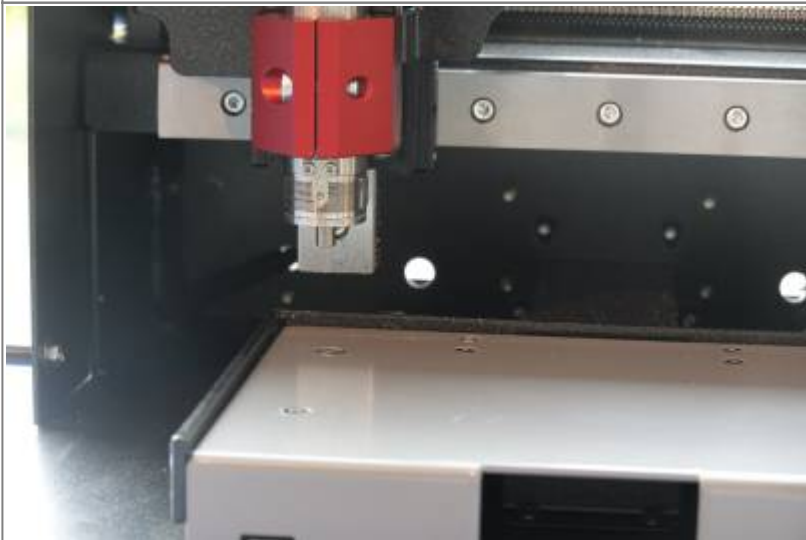
| Image | Description |
|---|---|
| | <p>Jog the spindle some distance away from the upper left corner, both in the X and the Y directions.</p> |

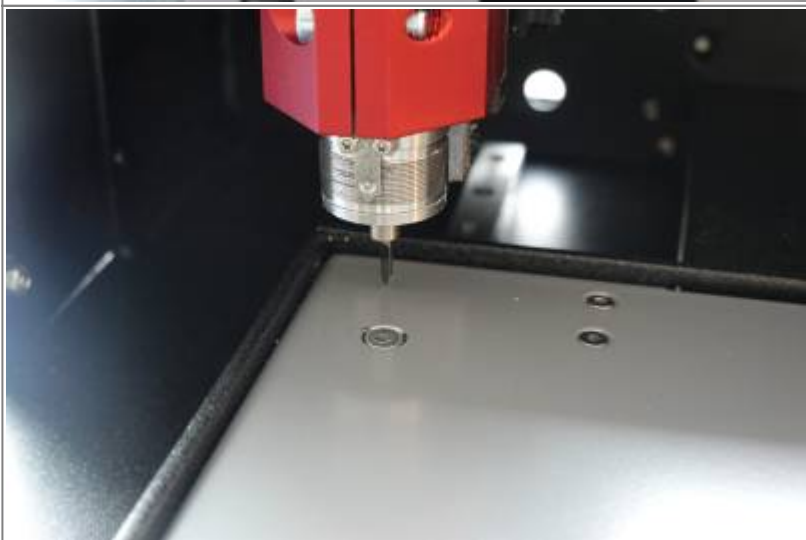
| Image | Description |
|---|---|
| | <p>Jog the Z-axis (the spindle) down till there is about 15 mm distance to the table surface.<br/>After that put an engraving cutter in the spindle.<br/>It will be sticking out of the spindle at the bottom.<br/>Loosen the cutter knob screw and push the cutter through the spindle till its tip is as close as possible to the table surface, but without touching it.</p> |

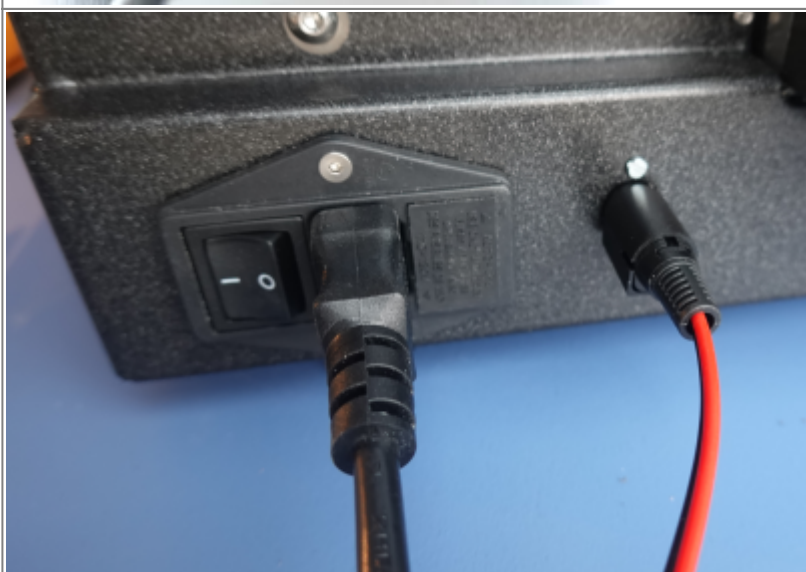
| Image | Description |
|---|---|
| | <p>Switch off the machine using the mains switch.</p> |

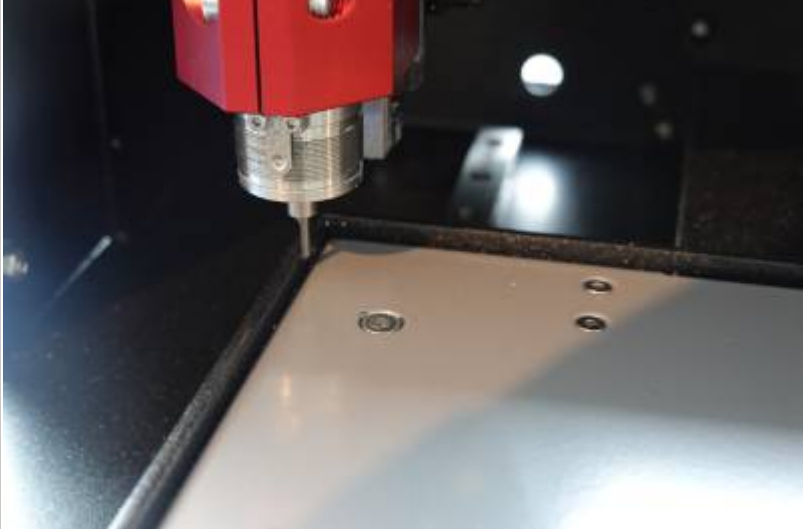
| Image | Description |
|---|---|
| | <p>Gently rotate the black knob on the back side of the X-axis stepper motor till the flat side of the cutter is well aligned with the left table stop.</p> |
