## The engraved data are not positioned correctly on the plate.

### To re-calibrate the X-axis home position, proceed as follows

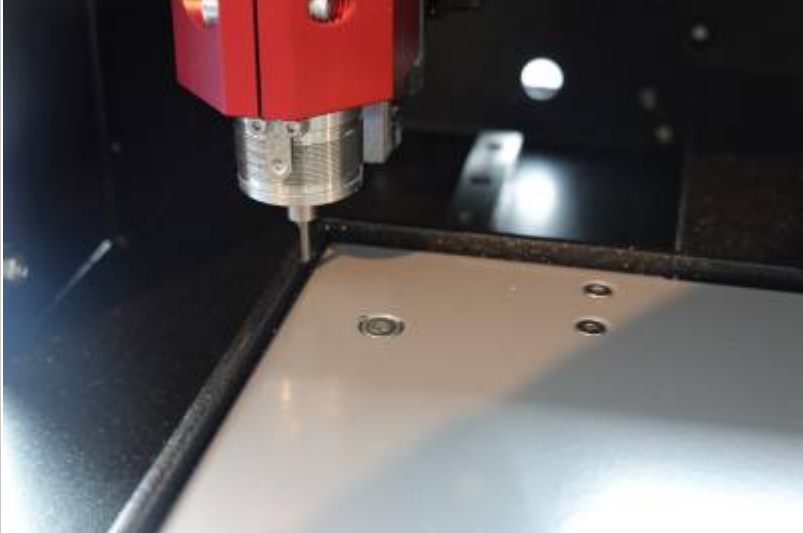
| Image | Description |
|---|---|
| | <p>Gently rotate the black knob on the back side of the X-axis stepper motor till the flat side of the cutter is well aligned with the left table stop.</p> |

- \* Gently rotate the black knob on the back side of the Y-axis stepper motor till the flat side of the cutter is well aligned with the top table stop.

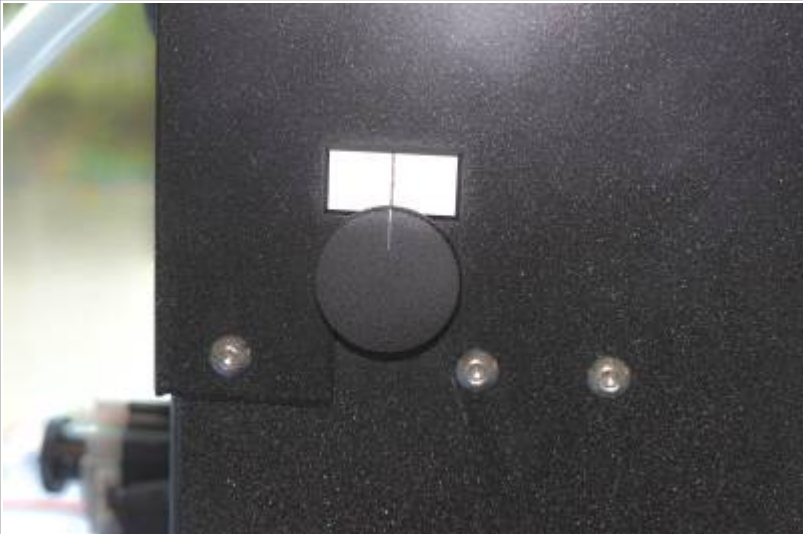
| Image | Description |
|---|---|
| | <p>Now check if the finely engraved line on this knob corresponds with the engraved line on the indicator plate. If that is not the case, loosen the black knob and rotate it to properly align it with the engraved indicator plate.</p> |

- \* Now check if the finely engraved line on this knob corresponds with the engraved line on the indicator plate. If that is not the case, loosen the black knob and rotate it to properly align it with the engraved indicator plate.
