## The engraved data are not positioned correctly on the plate.

### To re-calibrate the X-axis home position, proceed as follows

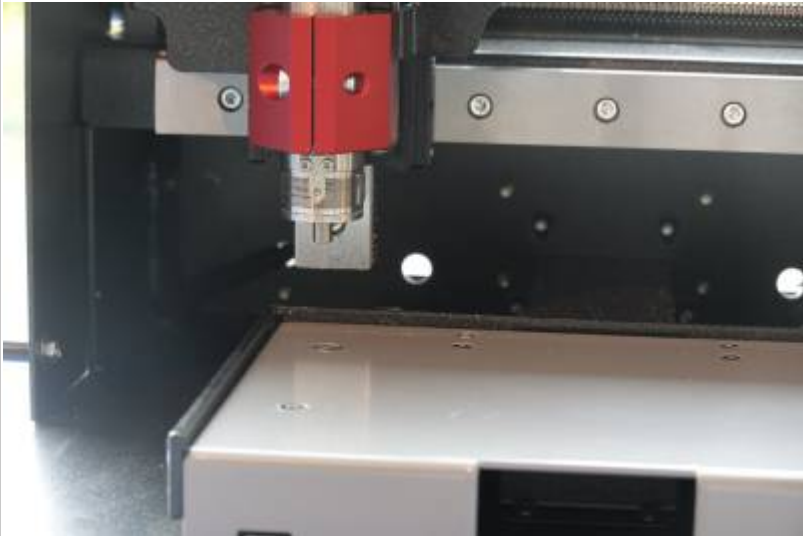
| Image | Description |
|---|---|
| | <p>Jog the spindle some distance away from the upper left corner, both in the X and the Y directions.</p> |

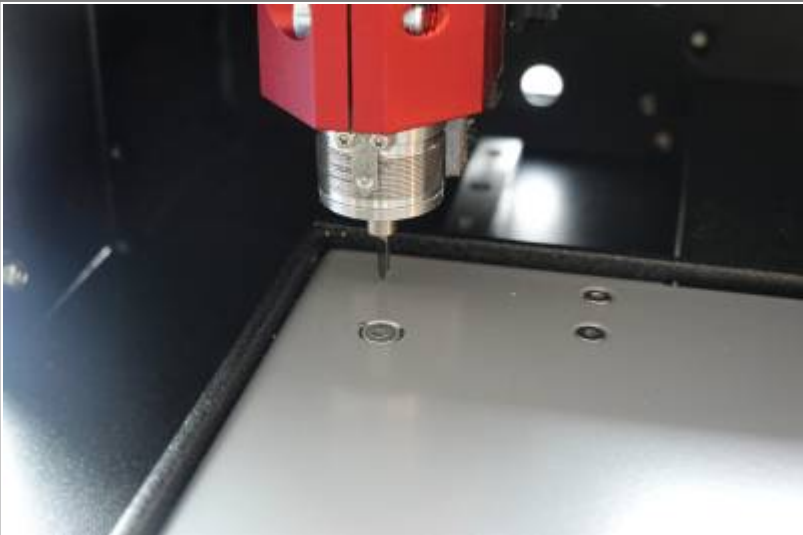
| Image | Description |
|---|---|
| | <p>Jog the Z-axis (the spindle) down till there is about 15 mm distance to the table surface.<br/>After that put an engraving cutter in the spindle.<br/>It will be sticking out of the spindle at the bottom.<br/>Loosen the cutter knob screw and push the cutter through the spindle till its tip is as close as possible to the table surface, but without touching it.</p> |

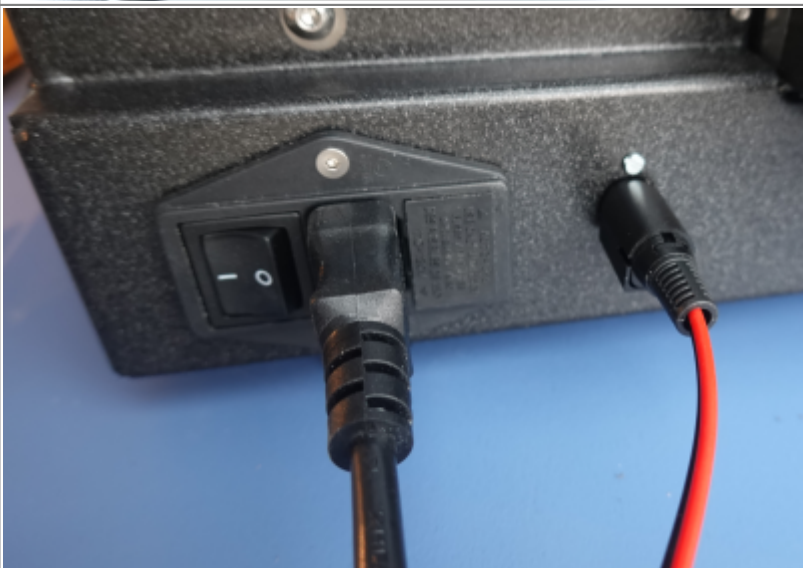
| Image | Description |
|---|---|
| | <p>Switch off the machine using the mains switch.</p> |
