## The engraved data are not positioned correctly on the plate.

### To re-calibrate the X-axis home position, proceed as follows

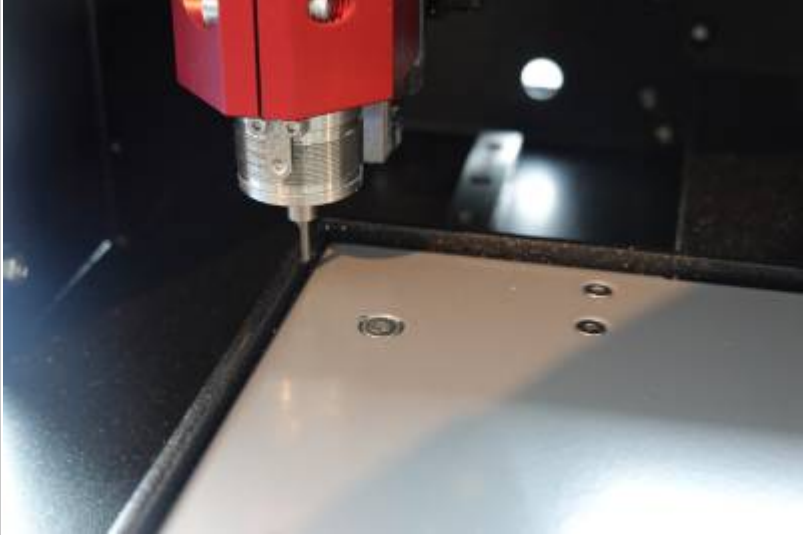
| Image | Description |
|---|---|
| | Gently rotate the black knob on the back side of the X-axis stepper motor till the flat side of the cutter is well aligned with the left table stop. |

- \* Gently rotate the black knob on the back side of the Y-axis stepper motor till the flat side of the cutter is well aligned with the top table stop.

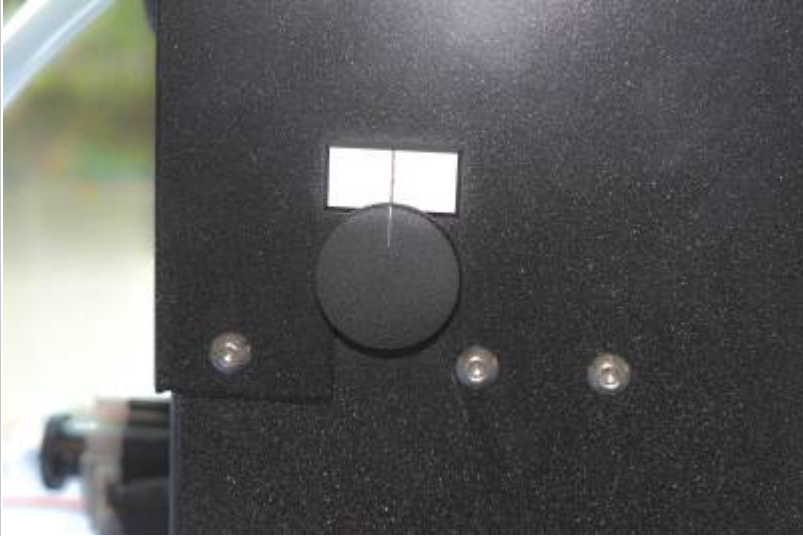
| Image | Description |
|---|---|
| | Now check if the finely engraved line on this knob corresponds with the engraved line on the indicator plate.<br>If that is not the case, loosen the black knob and rotate it to properly align it with the engraved indicator plate. |

- \* Now check if the finely engraved line on this knob corresponds with the engraved line on the indicator plate. If that is not the case, loosen the black knob and rotate it to properly align it with the engraved indicator plate.
