## The engraved data are not positioned correctly on the plate.

### To re-calibrate the X-axis home position, proceed as follows

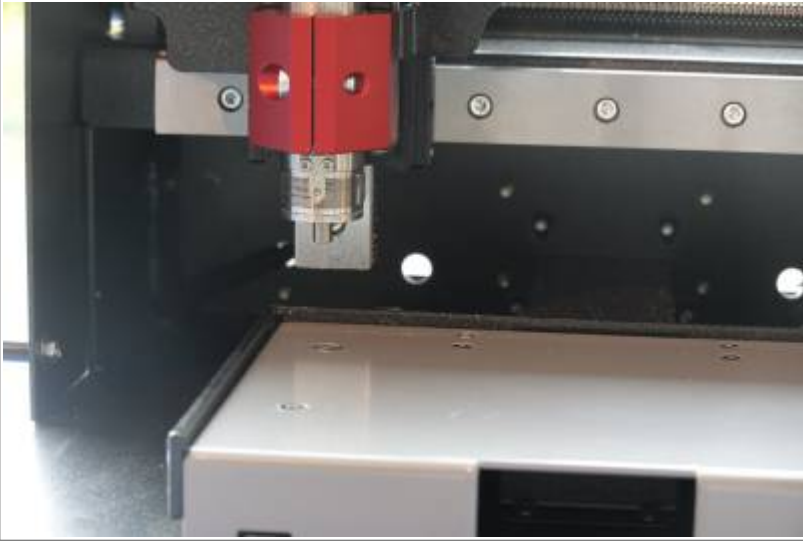
| Image | Description |
|---|---|
| | <p>Jog the spindle some distance away from the upper left corner, both in the X and the Y directions.</p> |

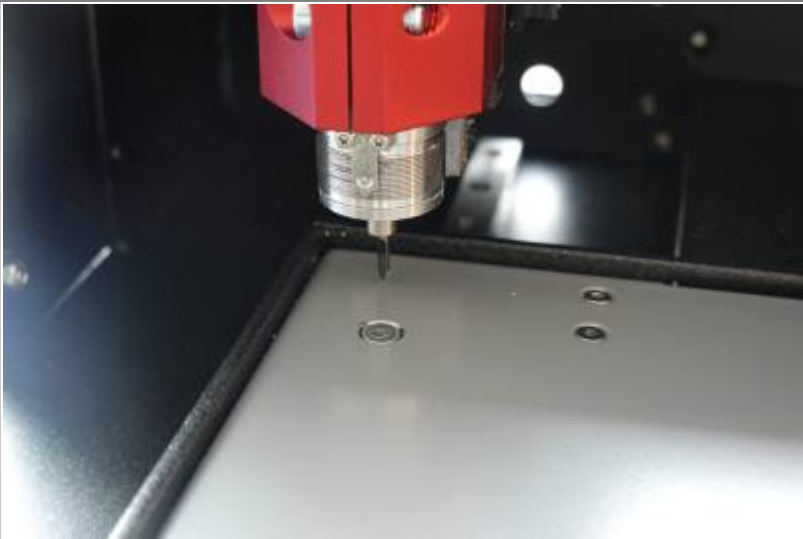
| Image | Description |
|---|---|
| | <p>Jog the Z-axis (the spindle) down till there is about 15 mm distance to the table surface.<br/>After that put an engraving cutter in the spindle.<br/>It will be sticking out of the spindle at the bottom.<br/>Loosen the cutter knob screw and push the cutter through the spindle till its tip is as close as possible to the table surface, but without touching it.</p> |
