## The engraved data are not positioned correctly on the plate.

### To re-calibrate the X-axis home position, proceed as follows

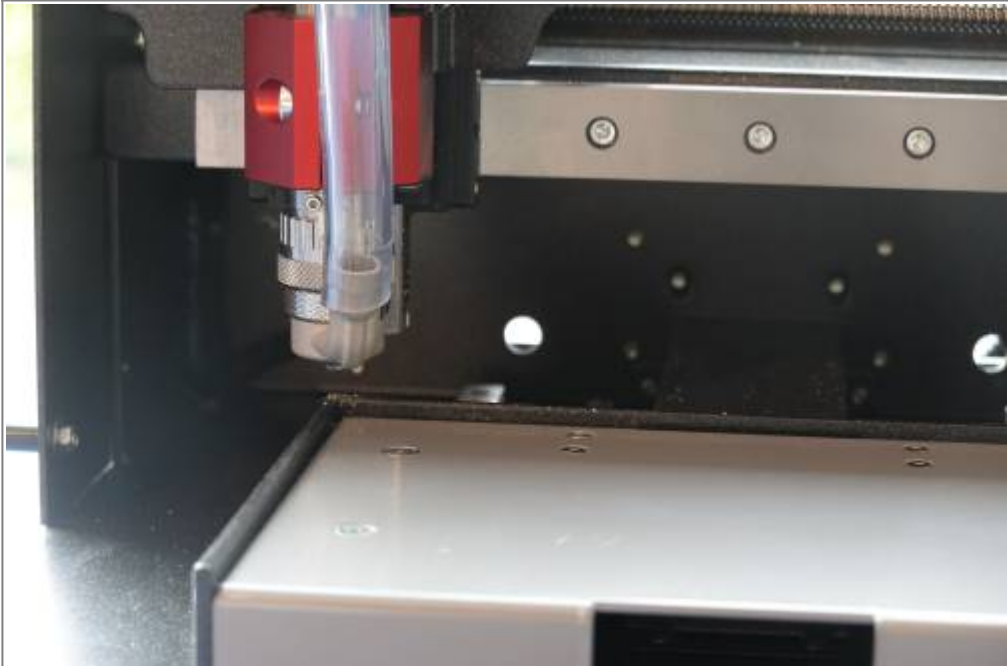
| Image | Description |
|---|---|
| | If there is an engraving plate and/or a Multimat on the engraving table, remove them. |

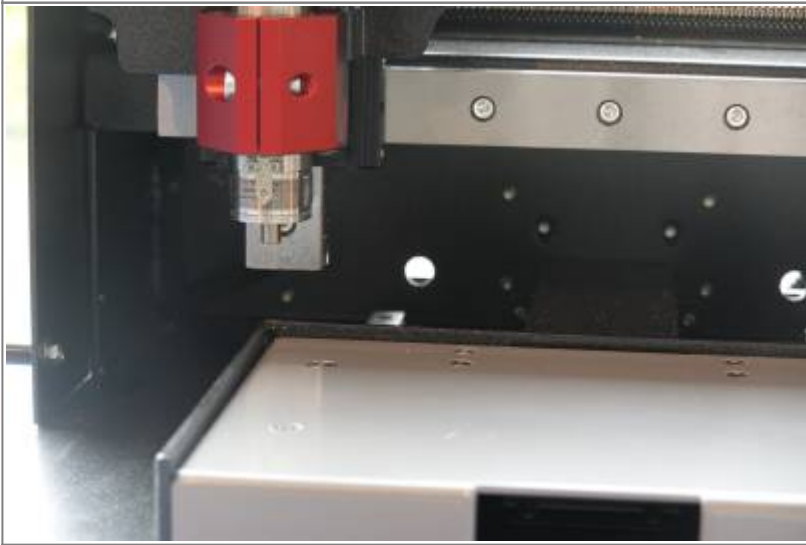
| Image | Description |
|---|---|
| | <p>Remove the depth regulator nose from the spindle.</p> |

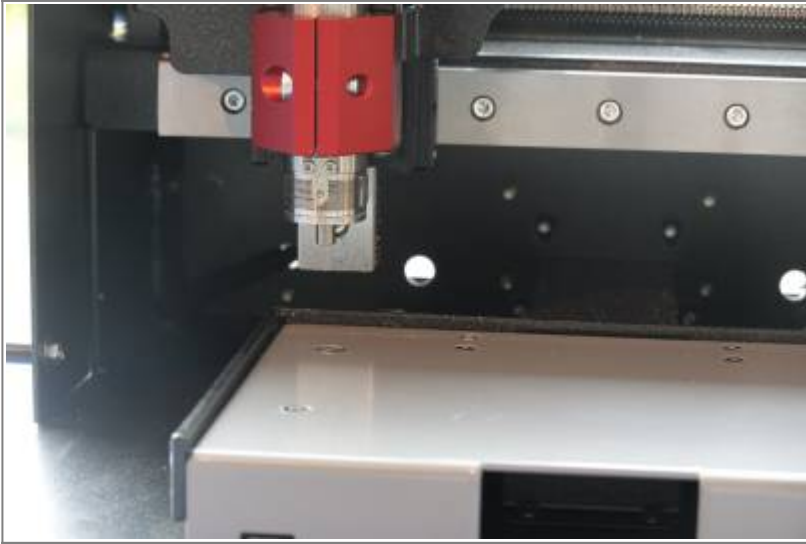
| Image | Description |
|---|---|
| | <p>Jog the spindle some distance away from the upper left corner, both in the X and the Y directions.</p> |

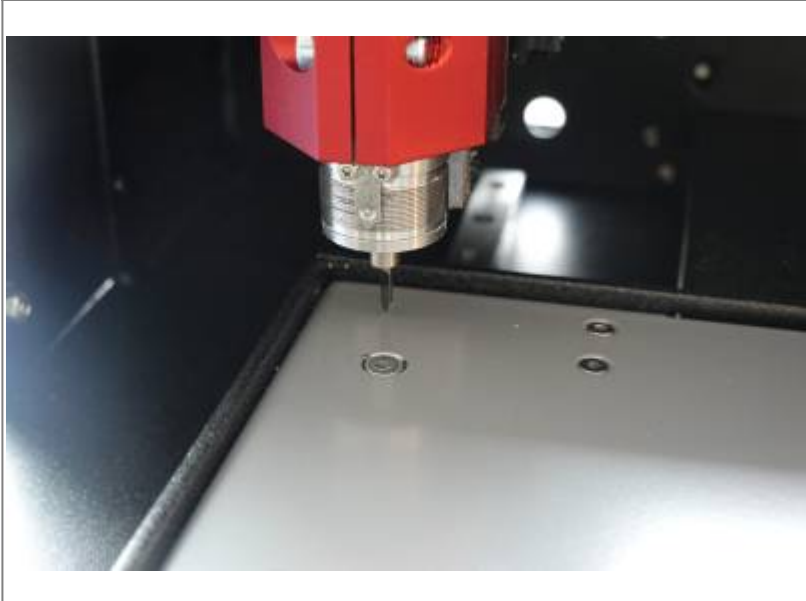
| Image | Description |
|---|---|
| | <p>Jog the Z-axis (the spindle) down till there is about 15 mm distance to the table surface.<br/>After that put an engraving cutter in the spindle.<br/>It will be sticking out of the spindle at the bottom.<br/>Loosen the cutter knob screw and push the cutter through the spindle till its tip is as close as possible to the table surface, but without touching it.</p> |

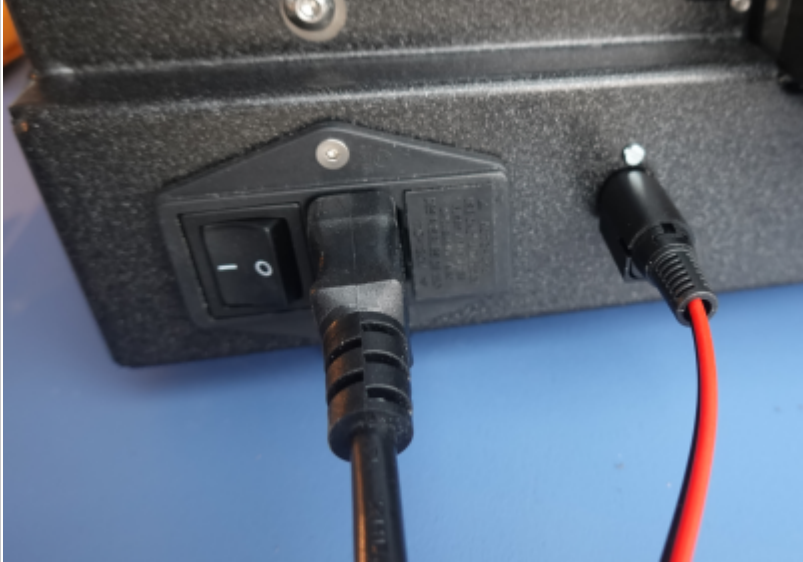
| Image | Description |
|---|---|
| | Switch off the machine using the mainswitch. |

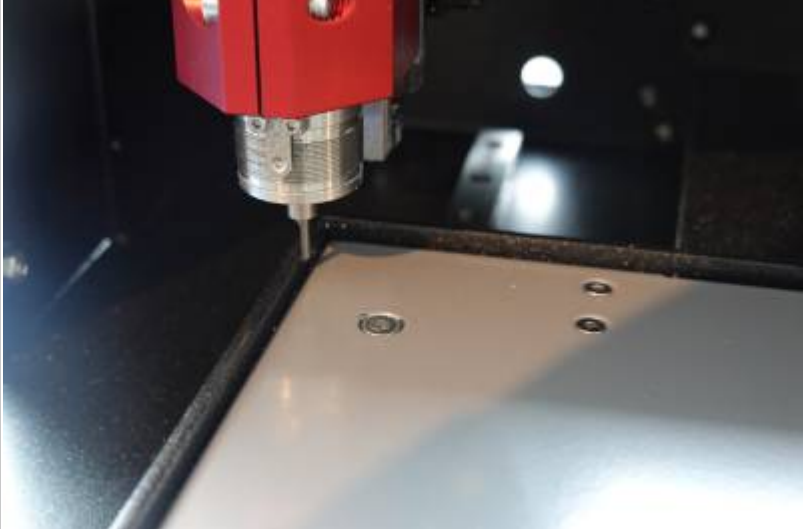
| Image | Description |
|---|---|
| | Gently rotate the black knob on the back side of the X-axis stepper motor till the flat side of the cutter is well aligned with the left table stop. |

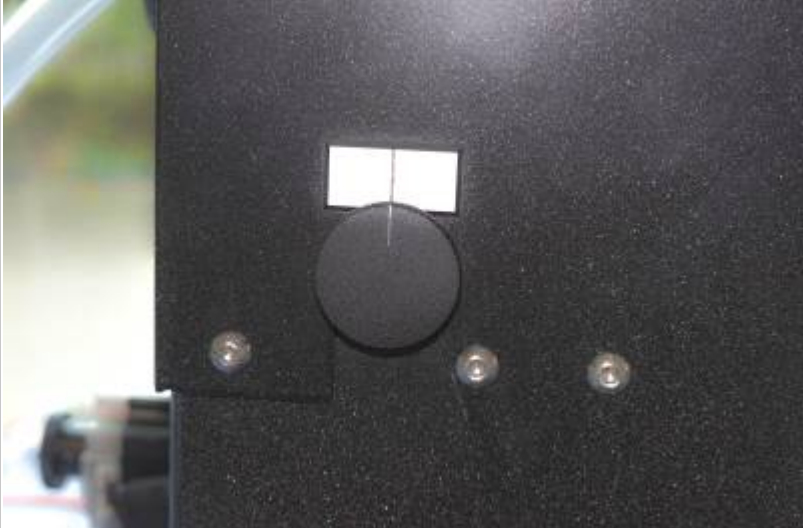
| Image | Description |
|---|---|
| | Now check if the finely engraved line on this knob corresponds with the engraved line on the indicator plate.<br>If that is not the case, loosen the black knob and rotate it to properly align it with the engraved indicator plate. |

| Image | Description |
|---|---|
| | Re-tighten this knob. |
