## The engraved data are not positioned correctly on the plate.

### To re-calibrate the X-axis home position, proceed as follows

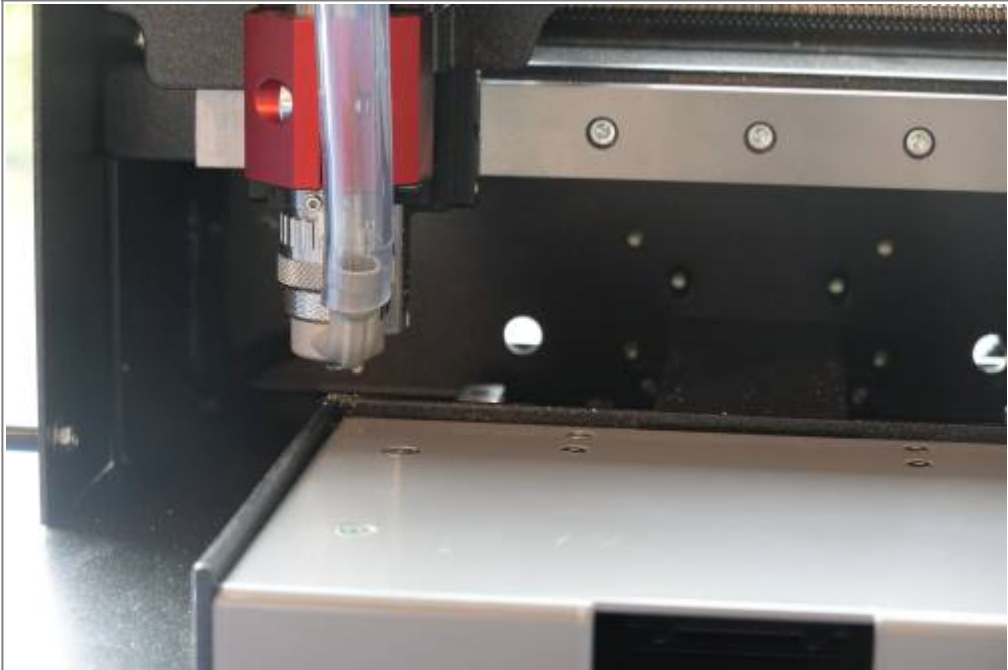
| Image | Description |
|---|---|
| | <p>If there is an engraving plate and/or a Multimat on the engraving table, remove them.</p> |

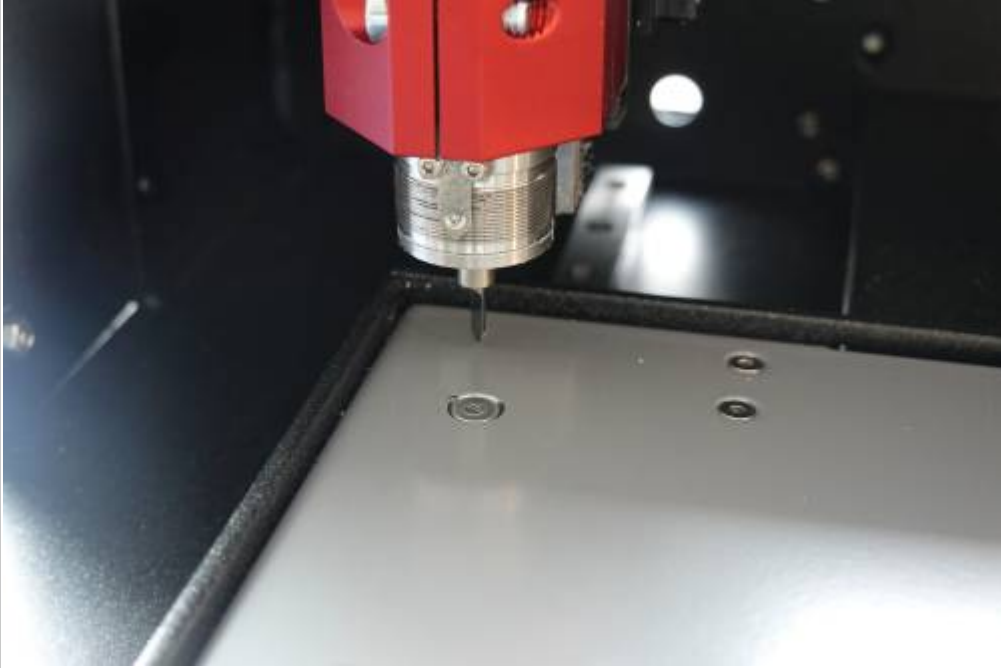
| Image | Description |
|---|---|
| | <p>Jog the Z-axis (the spindle) down till there is about 15 mm distance to the table surface.<br/>After that put an engraving cutter in the spindle.<br/>It will be sticking out of the spindle at the bottom.<br/>Loosen the cutter knob screw and push the cutter through the spindle till its tip is as close as possible to the table surface, but without touching it.</p> |

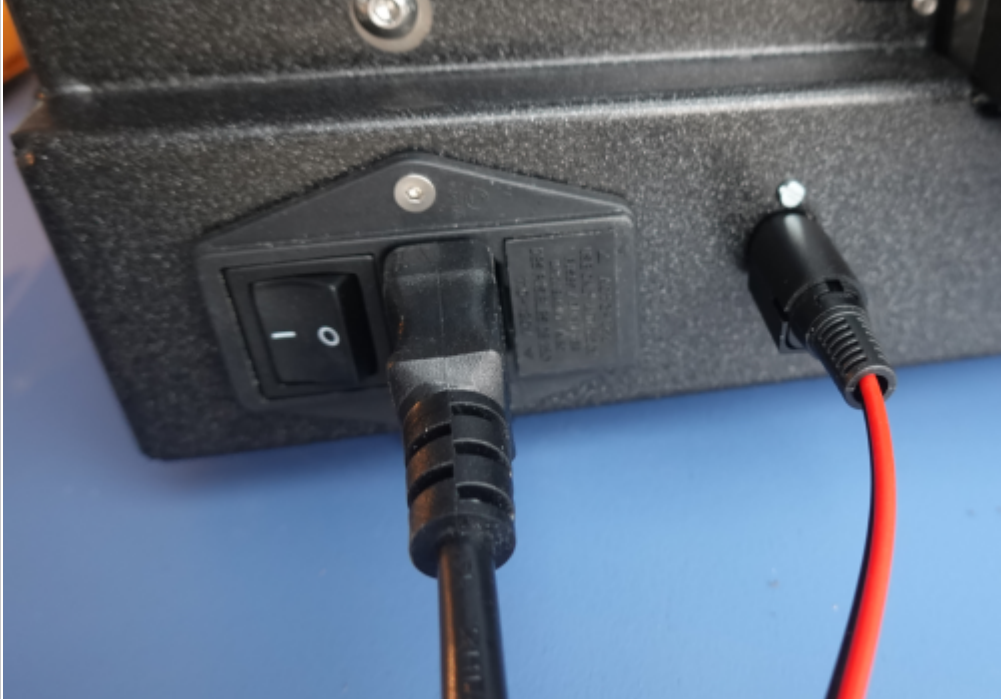
| Image | Description |
|---|---|
| | <p>Switch off the machine using the mains switch.</p> |
