## The engraved data are not positioned correctly on the plate.

### To re-calibrate the X-axis home position, proceed as follows

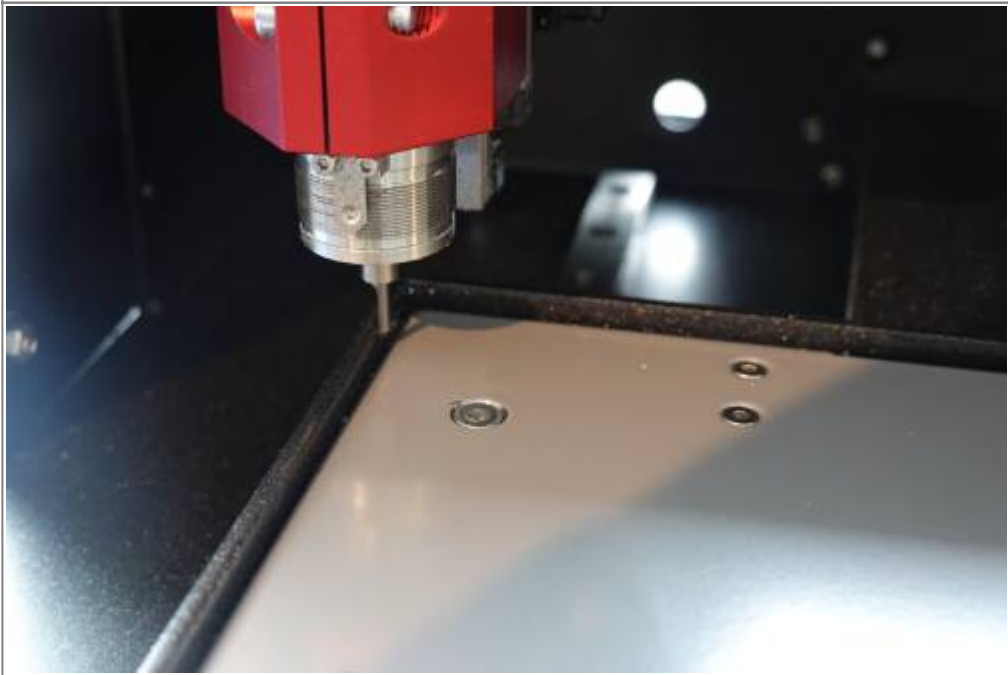
| Image | Description |
|---|---|
| | Gently rotate the black knob on the back side of the X-axis stepper motor till the flat side of the cutter is well aligned with the left table stop. |

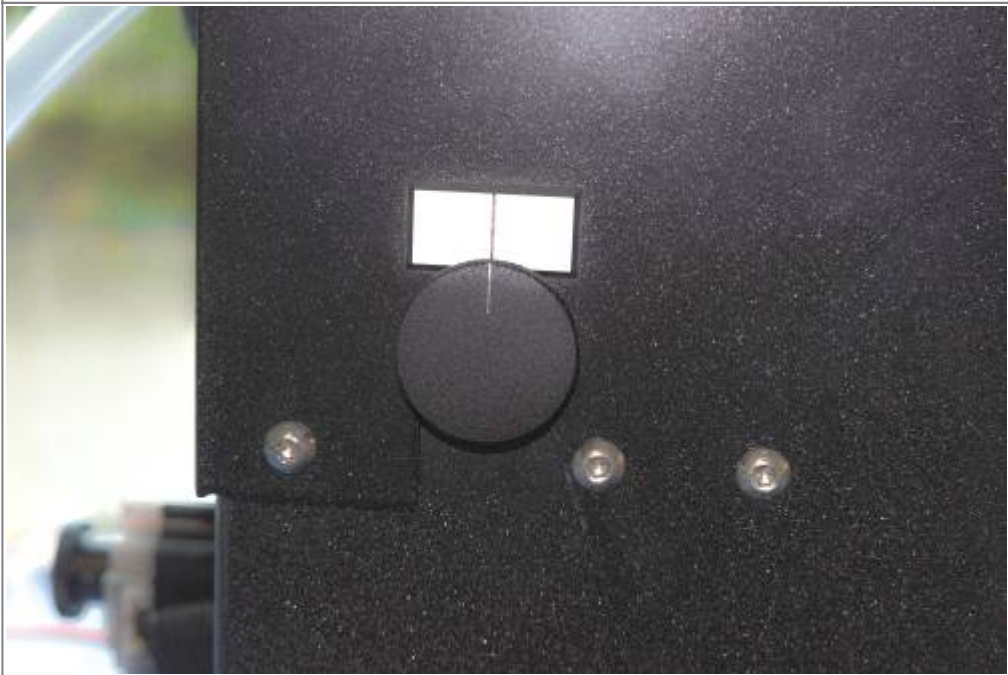
| Image | Description |
|---|---|
| | Now check if the finely engraved line on this knob corresponds with the engraved line on the indicator plate.<br>If that is not the case, loosen the black knob and rotate it to properly align it with the engraved indicator plate. |
| | Re-tighten this knob. |
