## The engraved data are not positioned correctly on the plate.

### To re-calibrate the X-axis home position, proceed as follows

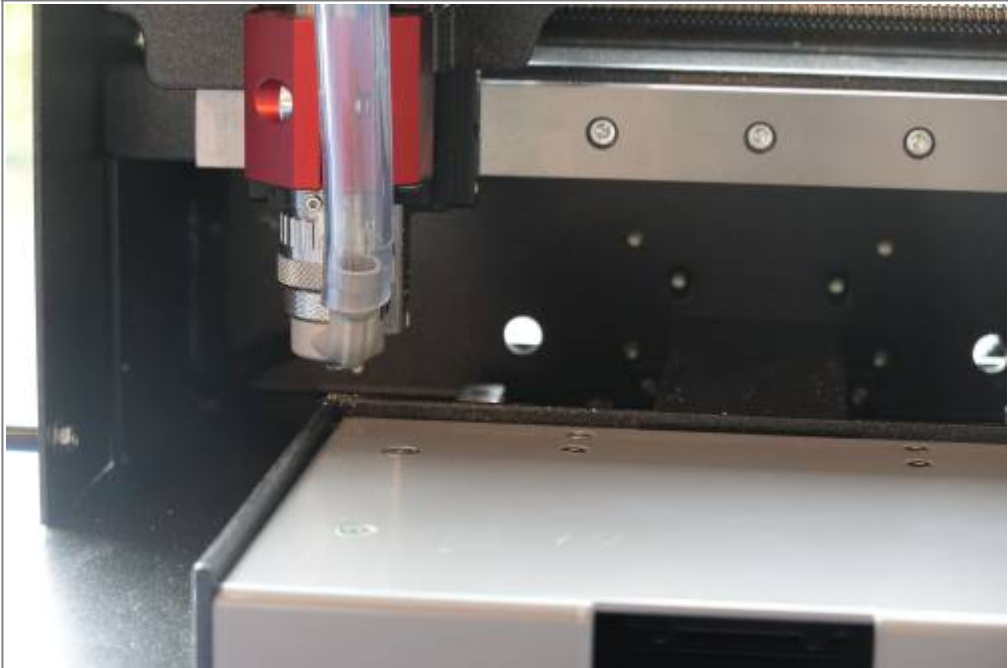
| Image | Description |
|---|---|
| | <p>If there is an engraving plate and/or a Multimat on the engraving table, remove them.</p> |

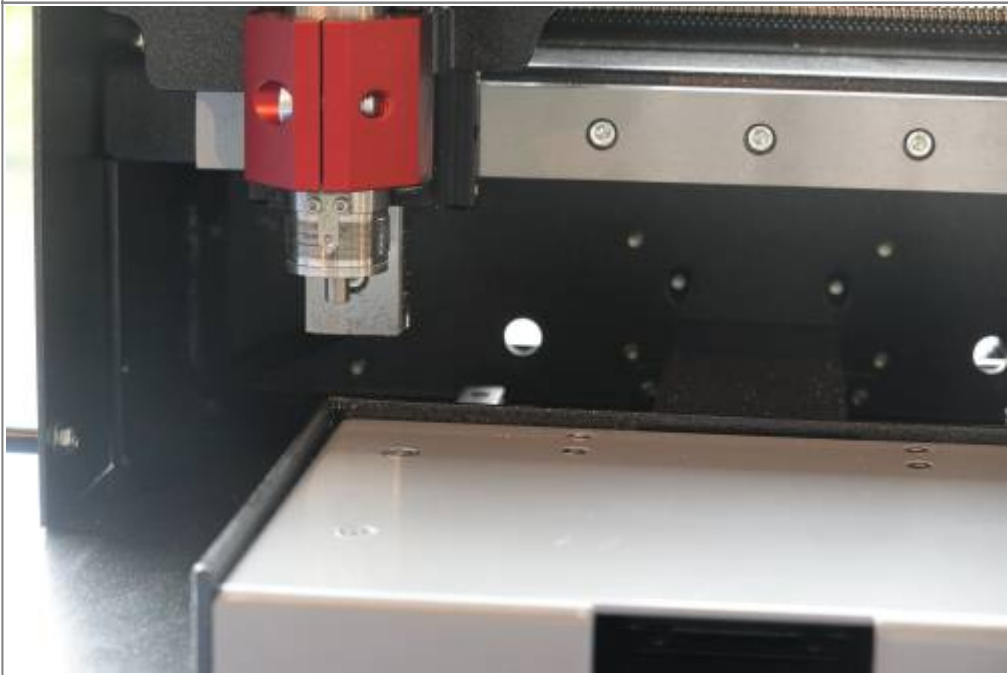
| Image | Description |
|---|---|
| | <p>Remove the depth regulator nose from the spindle.</p> |

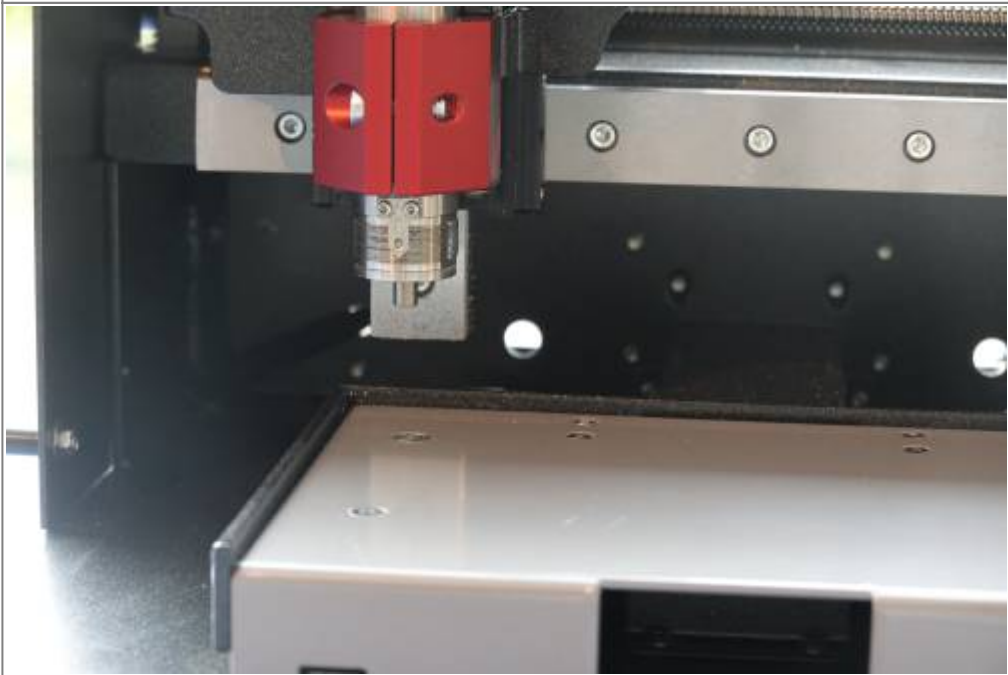
| Image | Description |
|---|---|
| | <p>Jog the spindle some distance away from the upper left corner, both in the X and the Y directions.</p> |

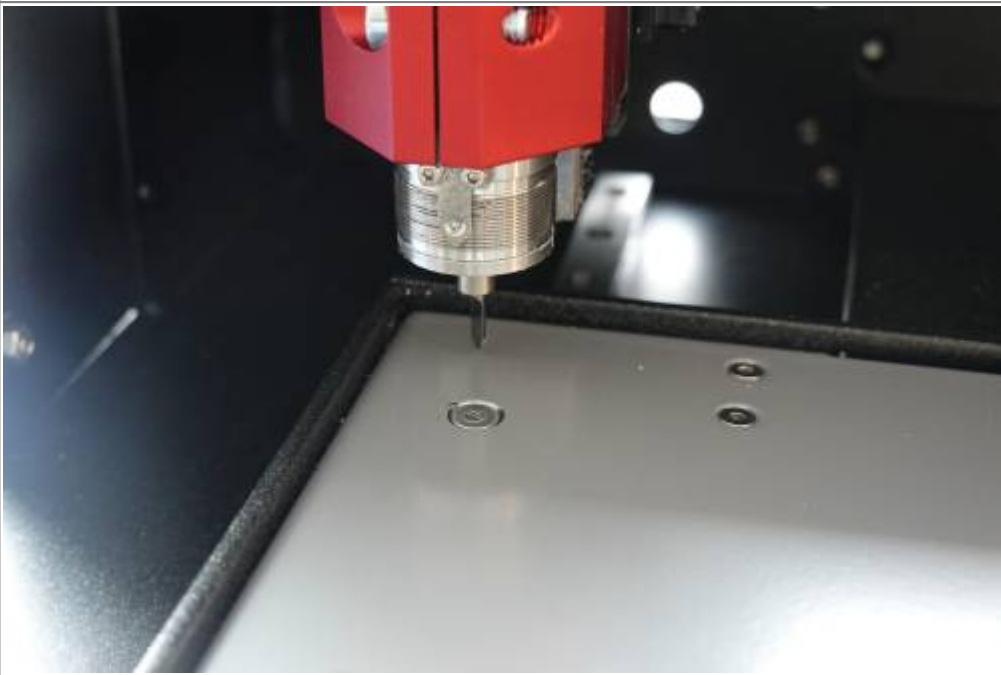
| Image | Description |
|---|---|
| | <p>Jog the Z-axis (the spindle) down till there is about 15 mm distance to the table surface.</p> <p>After that put a cutter knob in the spindle.</p> <p>Then gently push a cutter through the cutter knob and the spindle. It has to stick out of the spindle at the bottom.</p> <p>Push the cutter through the spindle till its tip is as close as possible to the table surface, but without touching it.</p> <p>Tighten the cutter knob screw.</p> |

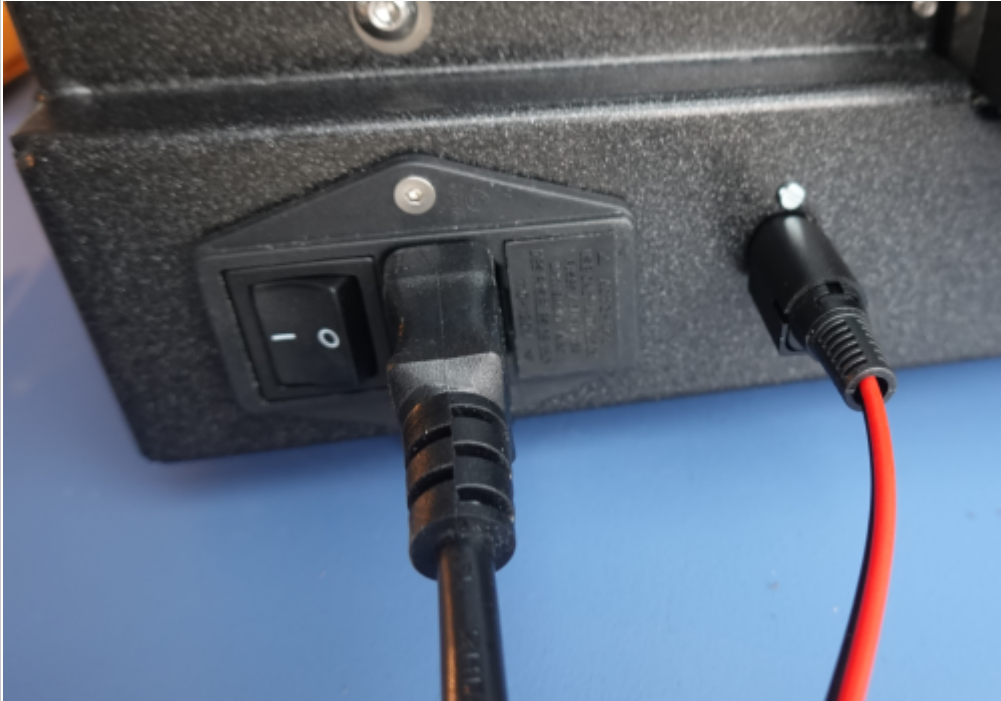
| Image | Description |
|---|---|
| | <p>Switch off the machine using the mains switch.</p> |

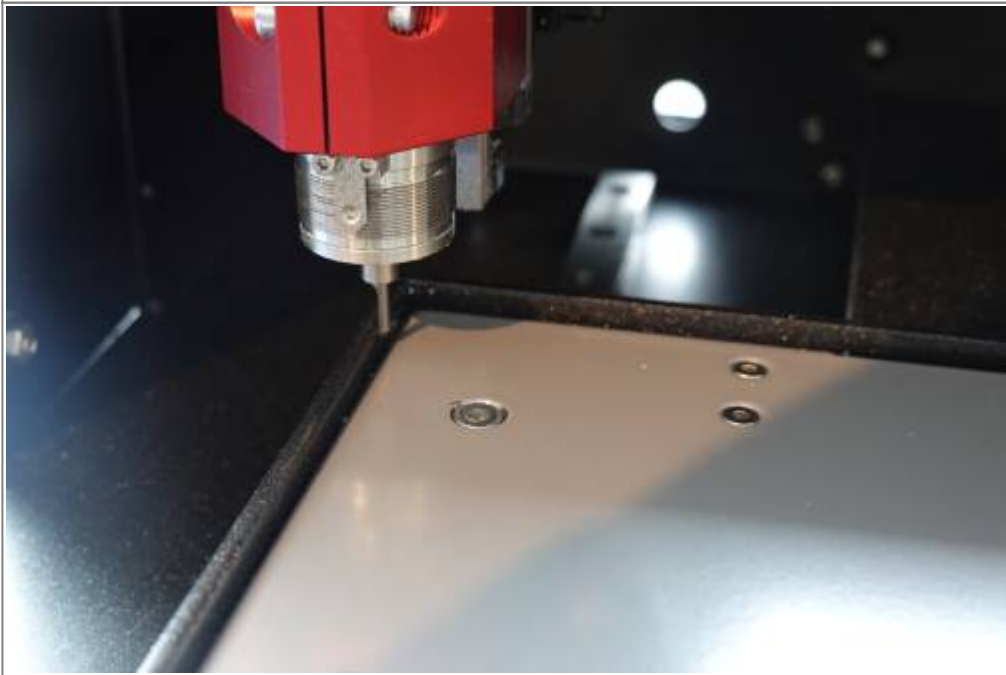
| Image | Description |
|---|---|
| | Gently rotate the black knob on the back side of the X-axis stepper motor till the flat side of the cutter is well aligned with the left table stop. |

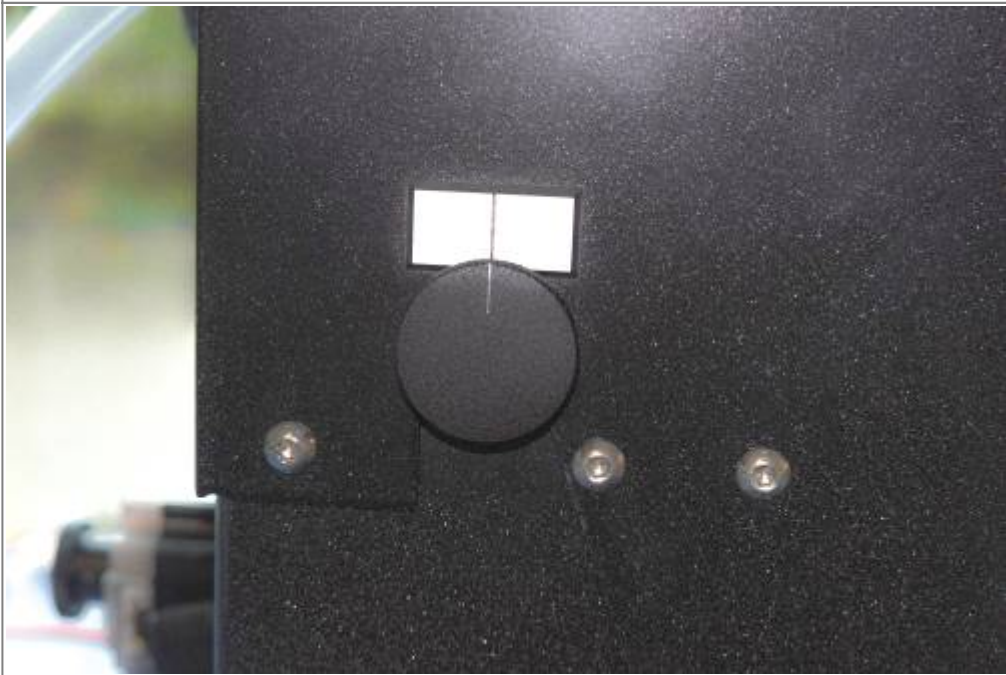
| Image | Description |
|---|---|
| | Now check if the finely engraved line on this knob corresponds with the engraved line on the indicator plate.<br>If that is not the case, loosen the black knob and rotate it to properly align it with the engraved indicator plate. |
| | Re-tighten this knob. |
