## The engraved data are not positioned correctly on the plate.

### To re-calibrate the X-axis home position, proceed as follows

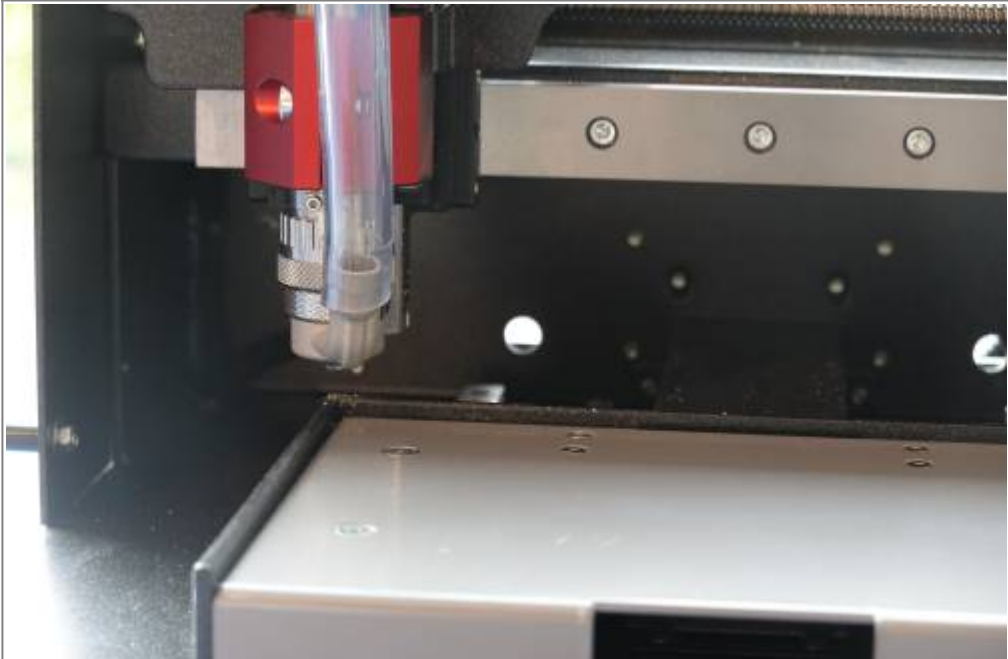
| Image | Description |
|---|---|
| | If there is an engraving plate and/or a Multimat on the engraving table, remove them. |

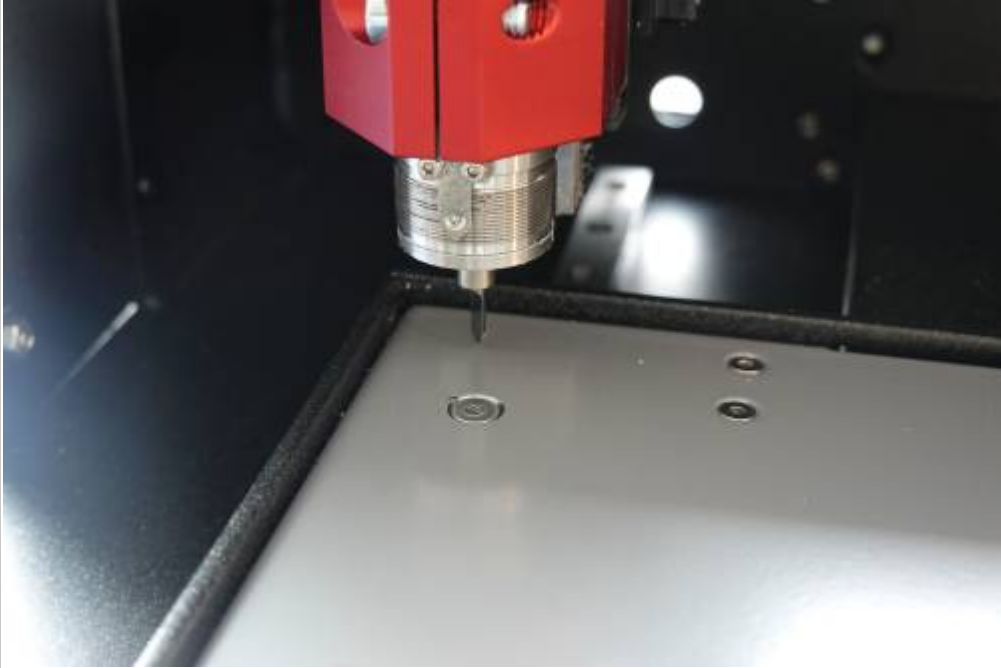
| Image | Description |
|---|---|
| | <p>Jog the Z-axis (the spindle) down till there is about 15 mm distance to the table surface.</p> <p>After that screw a cutter knob counter clockwise in the spindle.</p> <p>Then gently push a cutter through the cutter knob and the spindle. It has to stick out of the spindle at the bottom.</p> <p>Push the cutter through the spindle till its tip is as close as possible to the table surface, but without touching it.</p> <p>Tighten the cutter knob screw.</p> |

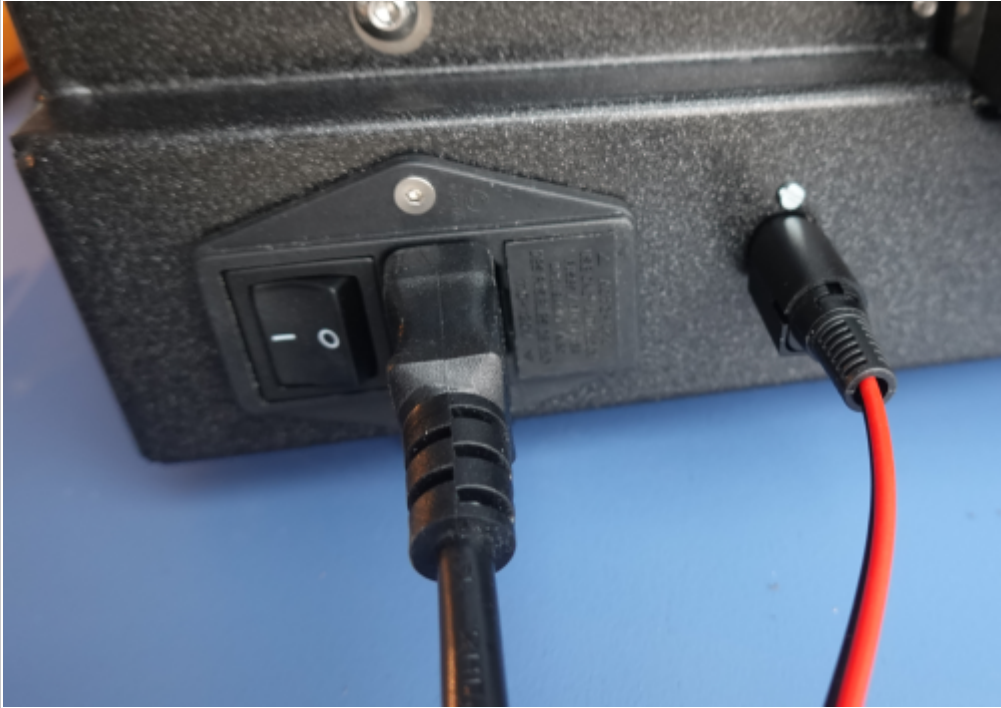
| Image | Description |
|---|---|
| | <p>Switch off the machine using the mains switch.</p> |
